# TECHNICAL SERVICE BULLETIN

<b>Subject</b>	800vRR Vehicle Controller V4.10.2 and ESM V3.0.7 Update
<b>Issue Date</b>	04/02/2024
<b>Service Bulletin Number</b>	SC-24-009
<b>Models Affected</b>	Service Specified Vehicles
<b>Complete By</b>	Next Service Opportunity
<b>Labor Operation Code</b>	EN70Z
<b>Description</b>	Software update for the 800vRRs Vehicle and Body Software to reduce the radiator fan current draw to 80%. Additionally fix a bug to properly route ESM faults away from the coolant light icon.

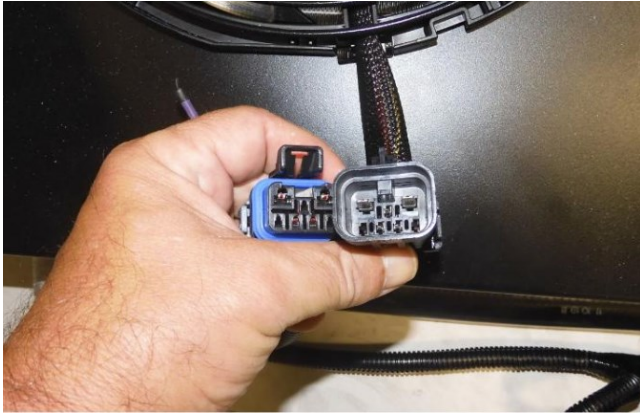
### Step 30 (Wiring Inspections):

Inspect each of the radiator fan terminals for any heat damage.

If any heat damage is found please take photos and escalate the findings to the back office support team.

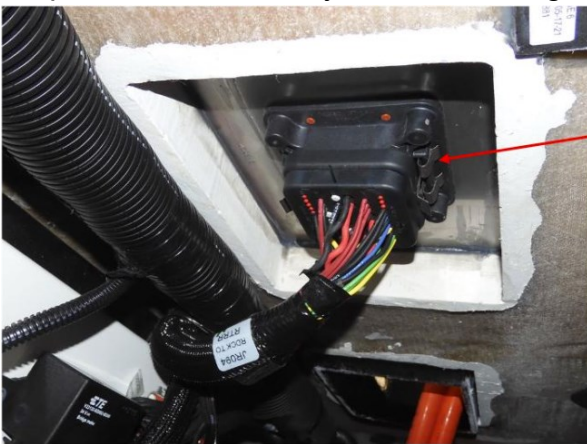
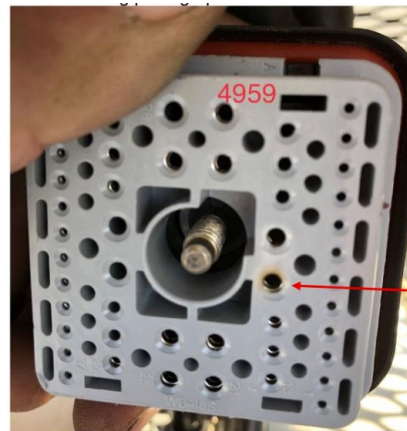
### Step 31:

Inspect the rear 48 way for heat damage in the connector body.

Metal Clip

Heat Damage

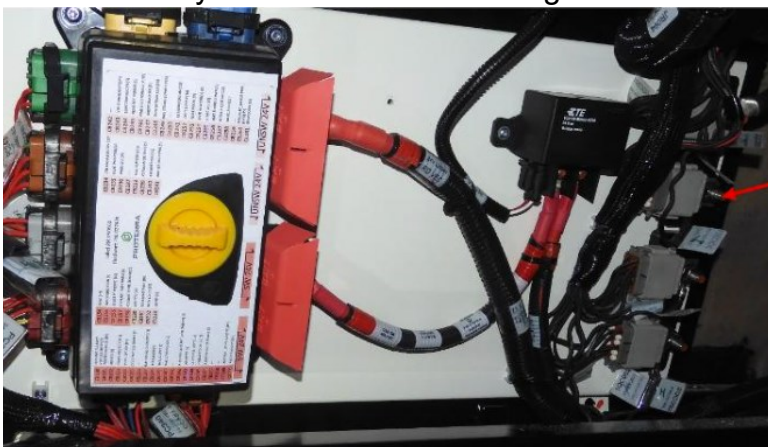
VEC Ground Bar

Finally the power and ground must be checked at the rear VEC. Please disconnect the corresponding plugs for the radiator fan circuitry and check the connector and pins for heat damage. The common plugs will be PC341, PC342, and PC337 the grounds 1QC001, 2QC001, and 3QC001. Check you schematics to verify due to model and configuration differences
