Inspection Form

Form FTA-IR-1

United States Department of Transportation
Federal Transit Administration

Inspection Date	YYYY	MM	DD	Report Number	20171201-WMATA-AG-1		
	2017	12	01				
Rail Agency Name	Washington Metropolitan Area Transit Authority			Rail Agency Department	TRST	Sub- Department	TKIN
Rail Agency Department Contact Information	Name		Email		Office Phone		Mobile Phone
	[REDACTED]		[REDACTED]		[REDACTED]		[REDACTED]
	[REDACTED]		[REDACTED]		[REDACTED]		[REDACTED]
	[REDACTED]		[REDACTED]		[REDACTED]		[REDACTED]
	[REDACTED]		[REDACTED]		[REDACTED]		[REDACTED]
Inspection Location	E-Line, Track 2, Greenbelt (E10) to College Park (E09)

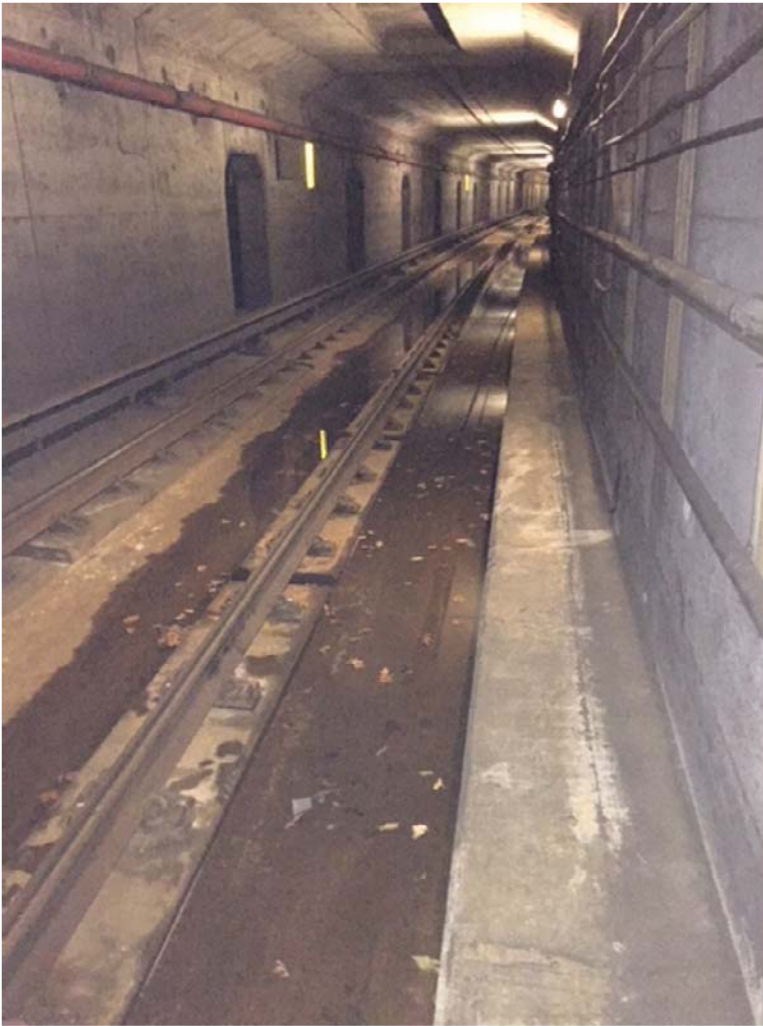
Figure 1: Blocked drains not draining as designed and allowing pooling water at F1 338+00.

Recommended Finding?	Yes			
							Remedial Action Required?	Yes			
							Recommended Reinspection?	Yes			
Remedial Action	To achieve compliance with WMATA's requirements <ul style="list-style-type: none"> WMATA must clear drain at F1 338+00.

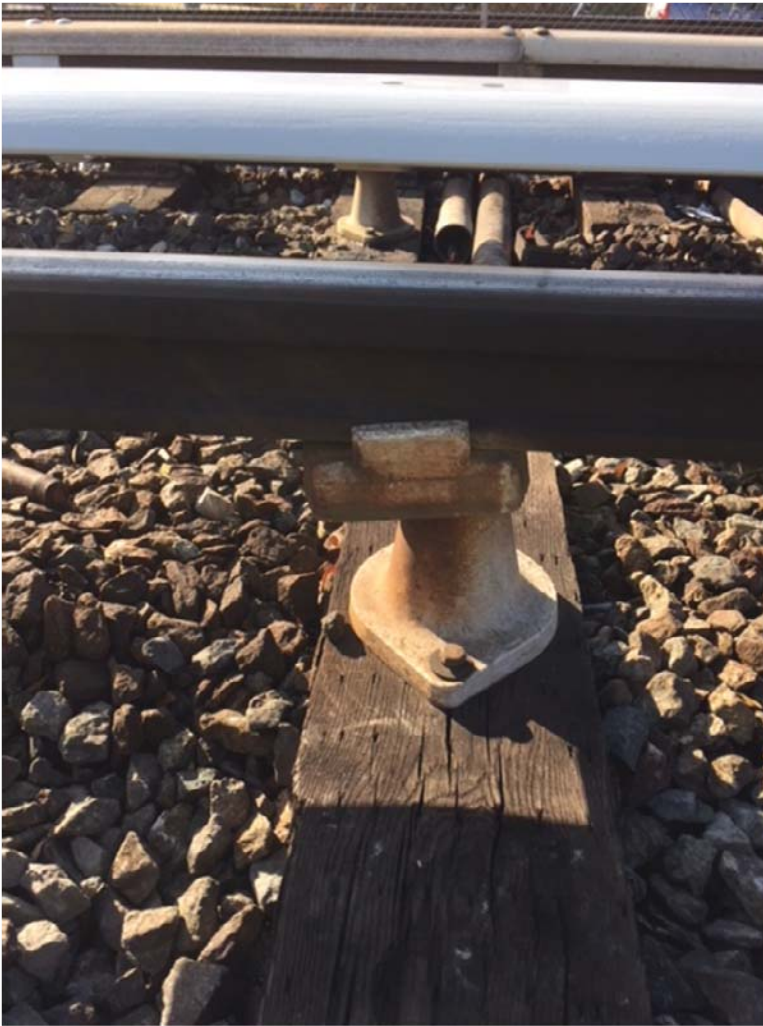
Figure 1: Defective insulator at B1 349+90.

Recommended Finding?	No		
								Remedial Action Required?	Yes		
								Recommended Reinspection?	Yes		
Remedial Action	To achieve compliance with WMATA's requirements <ul style="list-style-type: none"> WMATA must replace the defective third rail insulator at B1 349+90.

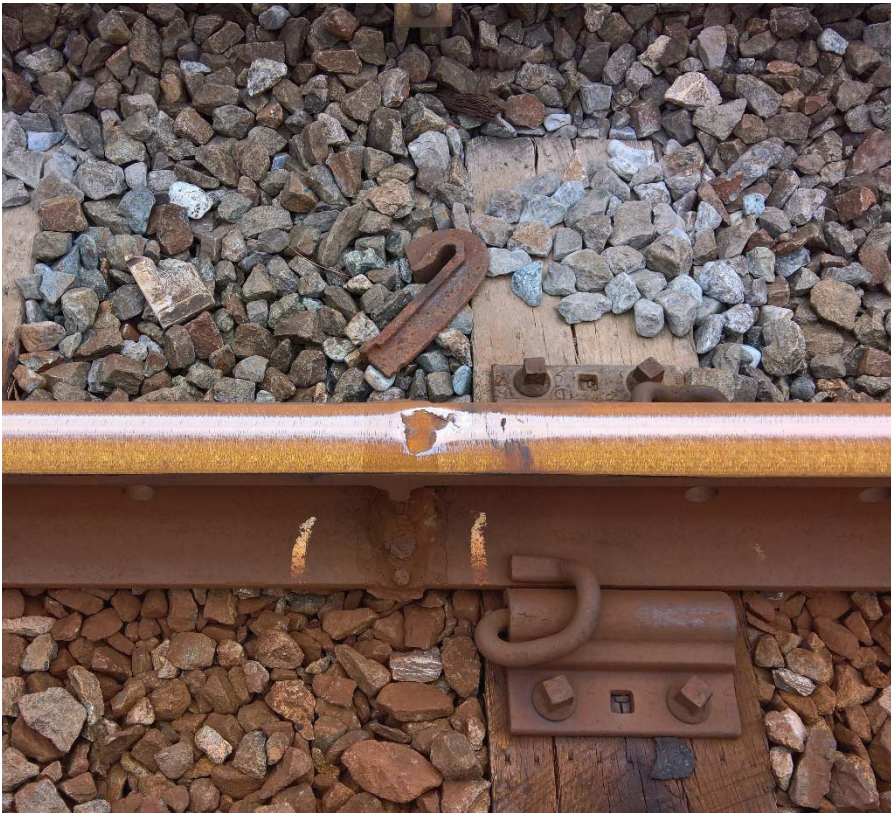
Figure 1: Chipped rail at CM B2 086+00.

Recommended Finding?	Yes				
								Remedial Action Required?	Yes				
								Recommended Reinspection?	Yes				
Remedial Action	To achieve compliance with WMATA's requirements: <ul style="list-style-type: none"> WMATA must address shelling condition at B2 086+00

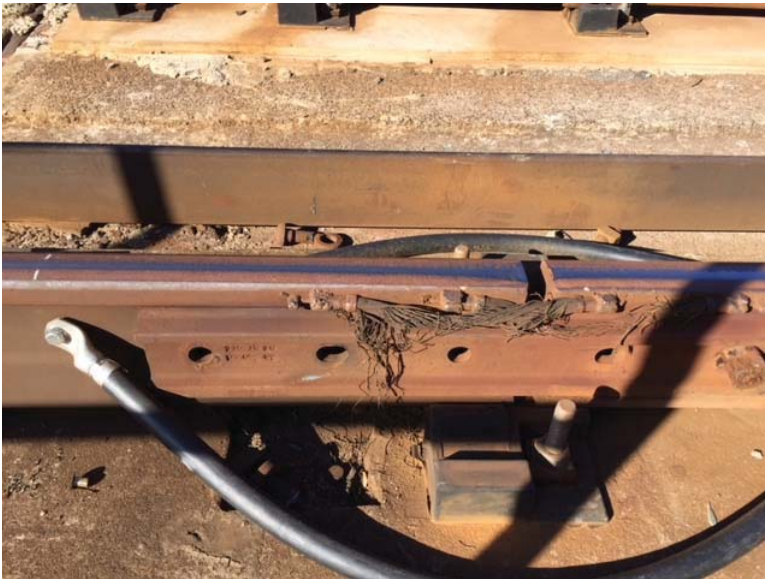
Figure 1: Missing bolts on the left rail joint at D2 468+20

Recommended Finding?	No		
								Remedial Action Required?	Yes		
								Recommended Reinspection?	Yes		
Remedial Action	<p>To achieve compliance with WMATA's requirements</p> <ul style="list-style-type: none"> WMATA must install two bolts to the rail joint at D2 468+20. WMATA must torque the loose fastener bolts between D2 463+50 and 463+70. WMATA must reinstall the downed chain marker at D2 413+00. WMATA must reinstall the missing third rail end approach coverboard at D2 413+00.

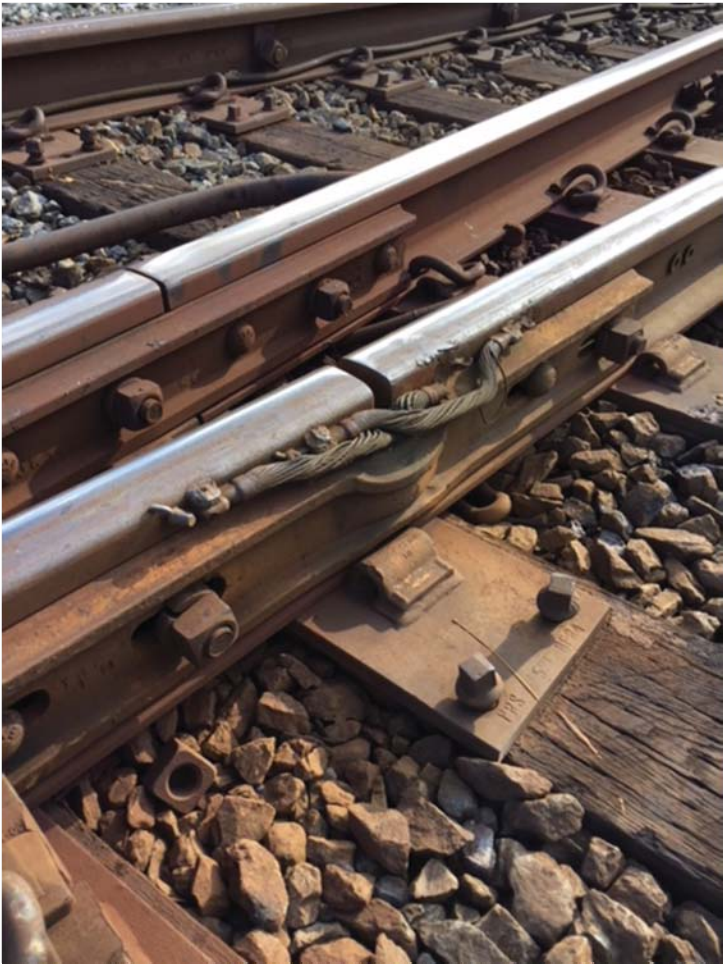
Figure 1: Incorrect joint bar and missing Pandrol clips at B2 258+00. 3B switch.

Recommended Finding?	No			
							Remedial Action Required?	Yes			
							Recommended Reinspection?	Yes			
Remedial Action	To achieve compliance with WMATA's requirements <ul style="list-style-type: none"> • WMATA must reinstall the downed chain marker at B2 252+00. • WMATA must install proper joint bars at the toe joint of the frog at the B2 258+00, 3B switch.

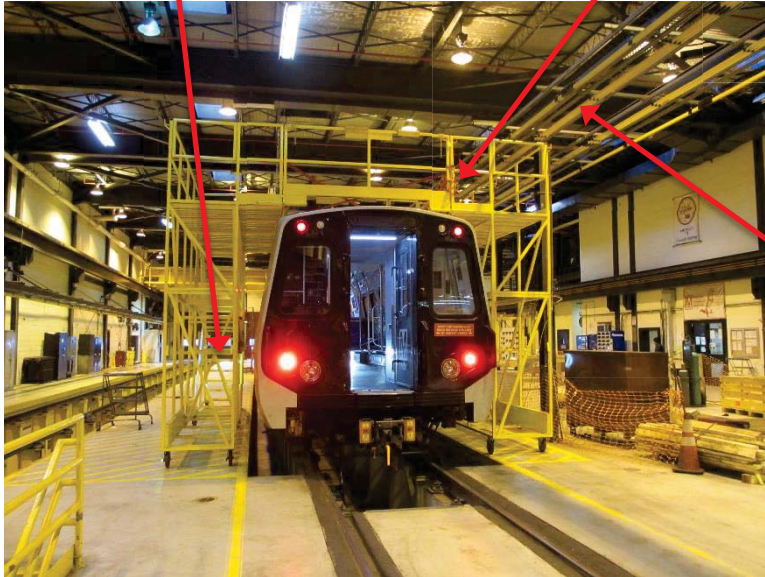
<p>FWSO Inspector conducted an inspection to follow up on WMATA progress for finding #17 regarding work being performed on 7000-series rail cars on scaffolding near the ceiling-mounted stinger power rail from the Tri-State Oversight Committee (TOC) audit conducted March 2017. The TOC CAP denoted that wheels were not locked on the scaffolding when the inspection was conducted.</p> <p>FWSO Inspector observed the following interim practices to abate safety risk while performing work on scaffolding:</p> <ul style="list-style-type: none"> • WMATA has placed a physical barrier to prevent inadvertent access to the side of the platform where the stinger power is located. Figure 1 below depicts the location of high voltage stinger power lines with respect to platform access and the barrier. • WMATA has stressed the importance of locking the wheels by placing signage on the access steps to the platform and that the equipment is special purpose and not to be used by untrained personnel. Figure 2 below depicts the reminder for employees to lock the casters. <p>FWSO Inspector was not able to verify a written procedure detailing proper use of scaffolding and was informed verbally that WMATA was in the process vetting a formal procedure internally within WMATA's configuration management process.</p> <p>The following non-color-coded defect was observed:</p> <ul style="list-style-type: none"> • WMATA has not addressed TOC finding #17 regarding work near the stinger. 	Recommended Finding?	No

Figure 1: 7000 Series rail car with portable (moveable) scaffolding

Remedial Action Required?	Yes
		Recommended Reinspection?	Yes
Remedial Action	<p>To achieve compliance with TOC finding #17:</p> <ul style="list-style-type: none"> • WMATA must provide a completed procedure detailing proper use of scaffolding at Shady Grove Yard (A99).

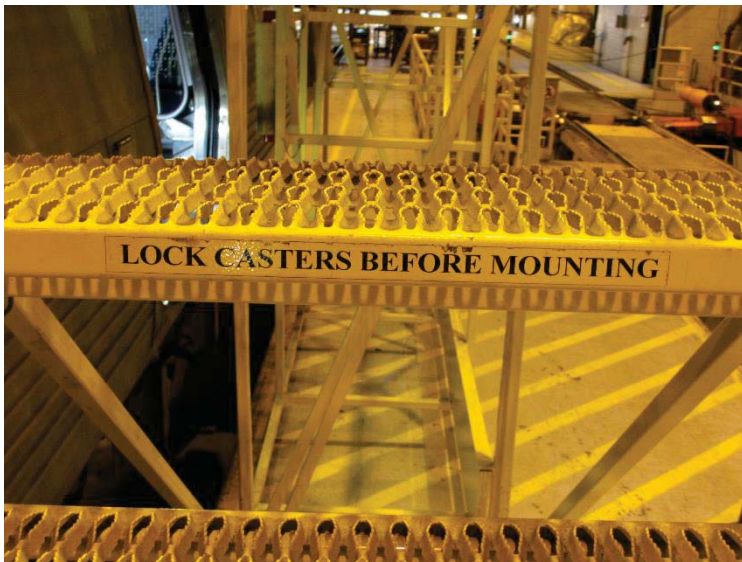
Figure 2: Warning labels on platform access steps

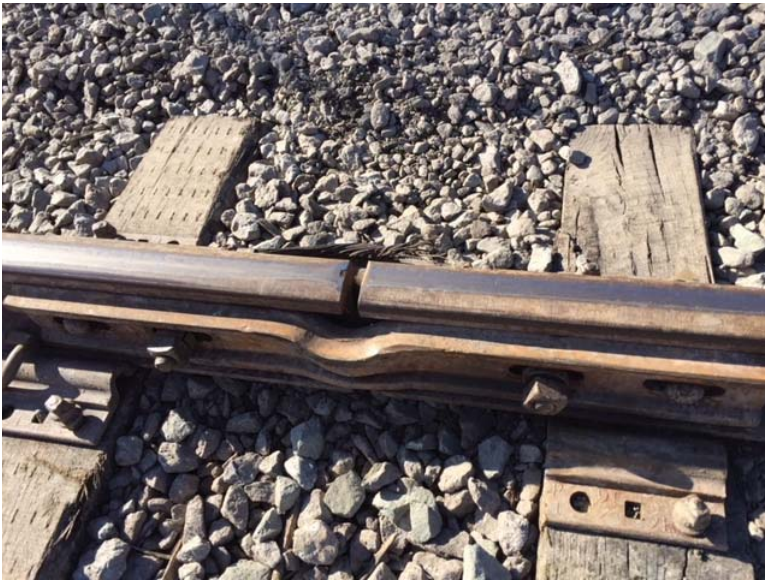
Figure 1: Improper joint bar at B2 294+80, right rail.

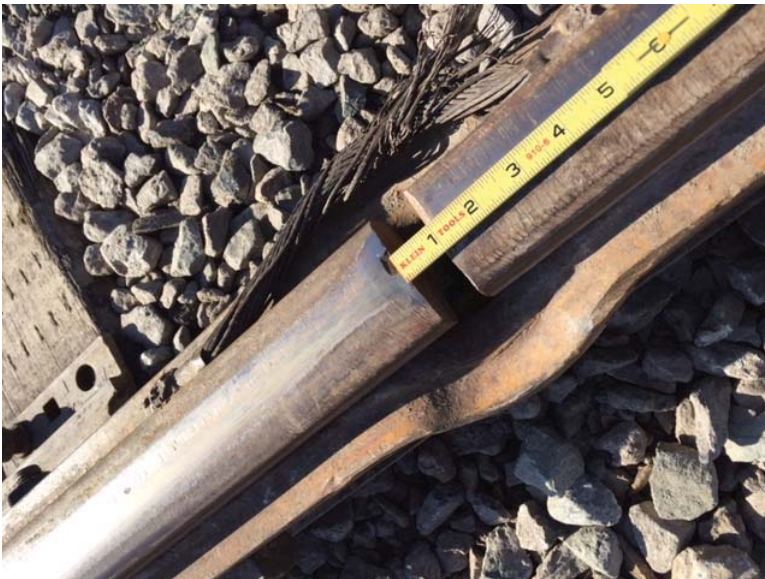
Figure 2: One-inch gap between rail running surfaces at B2 294+80, right rail.
