Inspection Form

United States Department of Transportation
Federal Transit Administration

Inspection Date	YYYY	MM	DD	Report Number	20170803-WMATA-AG-1		
	2017	08	03				
Rail Agency Name	Washington Metropolitan Area Transit Authority			Rail Agency Department	TRPM	Sub- Department	CM
Rail Agency Department Contact Information	Name		Email		Office Phone		Mobile Phone
	[REDACTED]		[REDACTED]		[REDACTED]		[REDACTED]
	[REDACTED]		[REDACTED]		[REDACTED]		[REDACTED]
	[REDACTED]		[REDACTED]		[REDACTED]		[REDACTED]
	[REDACTED]		[REDACTED]		[REDACTED]		[REDACTED]
Inspection Location	L'Enfant Plaza (D03) Alternating Current (AC) Switchboard Room #2

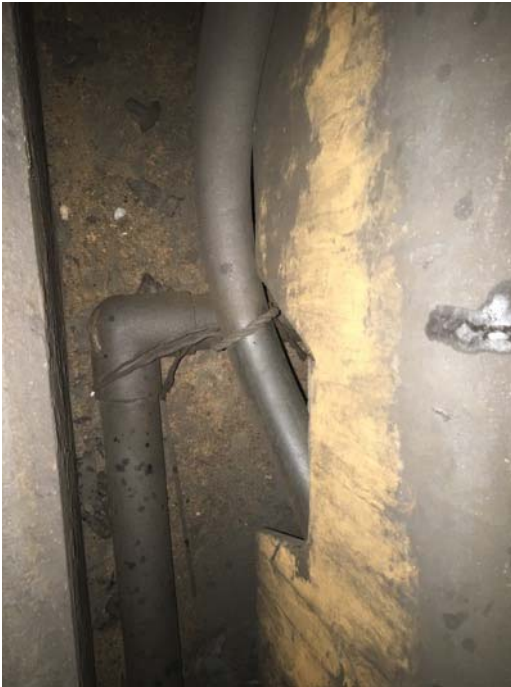
FIGURE 1 - C1 265+00 – TEMPORARY ROPE ON CABLE TO LIFT IT OFF THE GROUND NEEDS REMOVAL AND KINDORF SHOULD BE USED.

<p>Recommended Finding?</p>	Yes
		<p>Remedial Action Required?</p>	Yes
		<p>Recommended Reinspection?</p>	Yes
<p>Remedial Action</p>	<p>To achieve compliance with WMATA's requirements:</p> <ul style="list-style-type: none"> • WMATA must remove relay rail pieces at C1 251+00 to C1 255+00. • WMATA must replace cover board at C1 277+00. • WMATA must mitigate water intrusion from tunnel ceiling at C1 277+00. • WMATA must replace bad fasteners at C1 278+00. • WMATA must cut anchor stud bolt to allowable length at C1 279+00. • WMATA must cut anchor stud bolt to allowable length at C1 280+00. • WMATA must replace cover board at C1 290+00. • WMATA must install cable per EMI at C1 265+00. • WMATA must replace cable at C1 267+00. • WMATA must install OZ Gedney bushings and heat shrink on conduit stub-ups at C1 276+00. • WMATA must install heat shrink on conduit stub-up at C1 276+00. • WMATA must replace broken orange boot power connection assembly at C1 277+00. • WMATA must cap unused conduit to prevent water infiltration at C1 290+00.

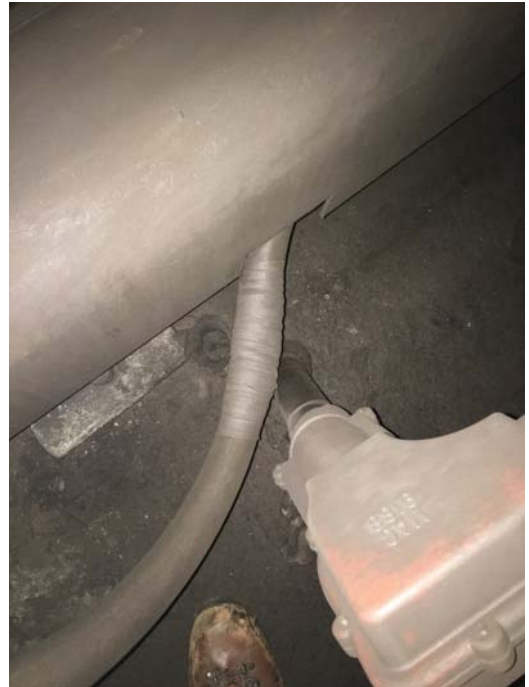
FIGURE 2 - C1 267+00 – FEEDER CABLE (PIGTAIL) HAS TEMPORARY REPAIR.

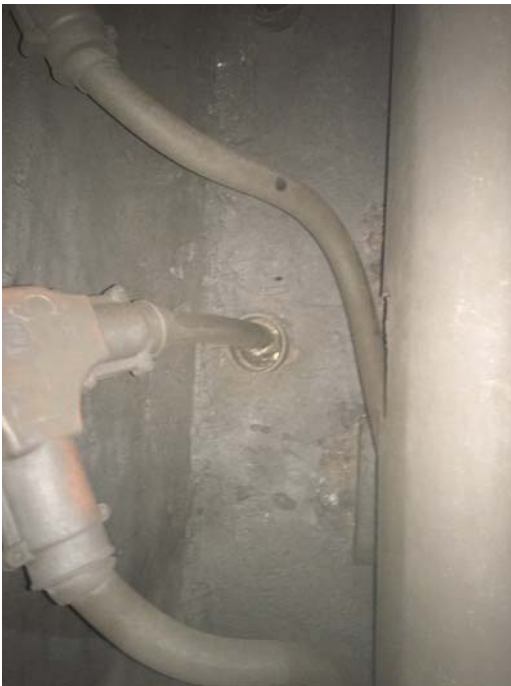
FIGURE 3 - C1 276+00 – FOUR CONDUIT STUB-UPS MISSING OZ GEDNEY BUSHINGS AND HEAT SHRINK

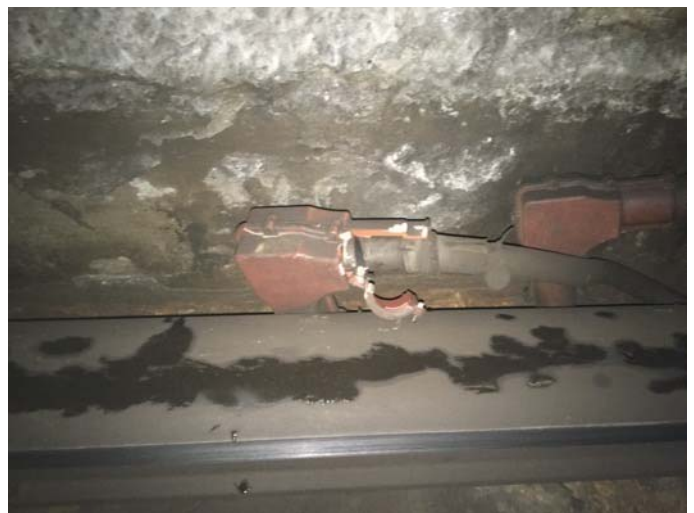
FIGURE 4 - C1 277+00 – ONE BROKEN ORANGE BOOT POWER CONNECTION ASSEMBLY

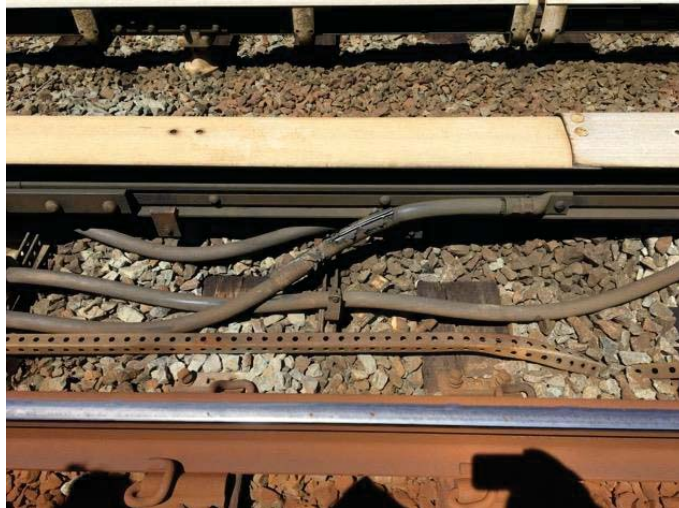
FIGURE 1 - J1 772+00 – EXPANSION CABLES ON GAUGE SIDE OF THIRD RAIL INSTALLED OFF THE GROUND WITH METAL KINDORF AND TEMPORARY REPAIR TO ONE EXPANSION CABLE.

<ul style="list-style-type: none">Expansion cables lying on the ground at J1 814+00.Expansion cables lying on the ground at J1 838+00.Expansion cables lying on the ground at J1 and J2 848+00.Expansion cables lying on the ground at J1 and J2 858+00. <p>The following remedial actions were verified as complete:</p> <ul style="list-style-type: none">Remedial Action #938: WMATA should install “No Clearance” signage on the bridge support wall between J1 CM763+00 and J1 CM767+00.Remedial Action #951: WMATA should repair or secure the trackside heater control box labeled: “HC-J03-52-3” that is smashed. The internal electrical components are exposed. Liquidite leading from the box into the conduit indicates 480 V.Remedial Action #1424: WMATA must replace cover on end approach of track 1, CM870+00, switch 1A.		
Remedial Action	To achieve compliance with WMATA’s requirements: <ul style="list-style-type: none">WMATA must install expansion cables per engineering EMI at J1 772+00.

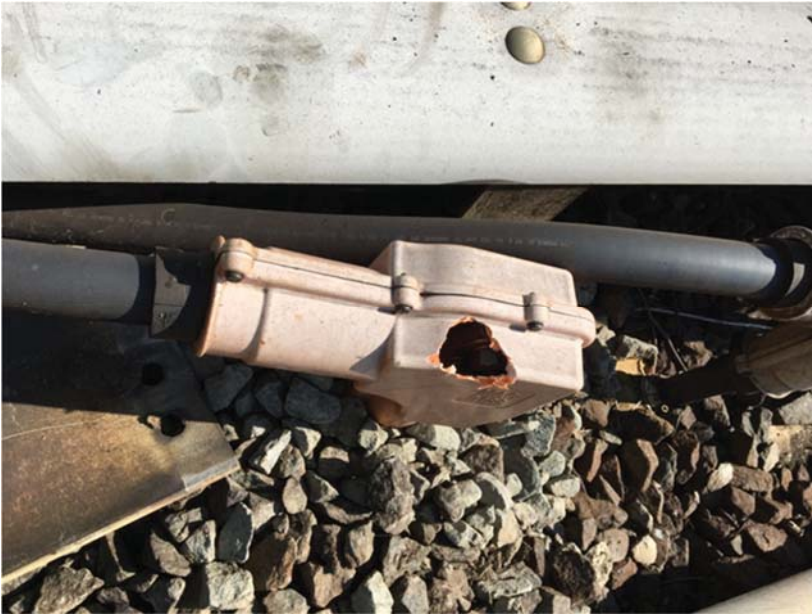
Figure 1: F2 398+00 – Broken Orange Boot Power Assembly

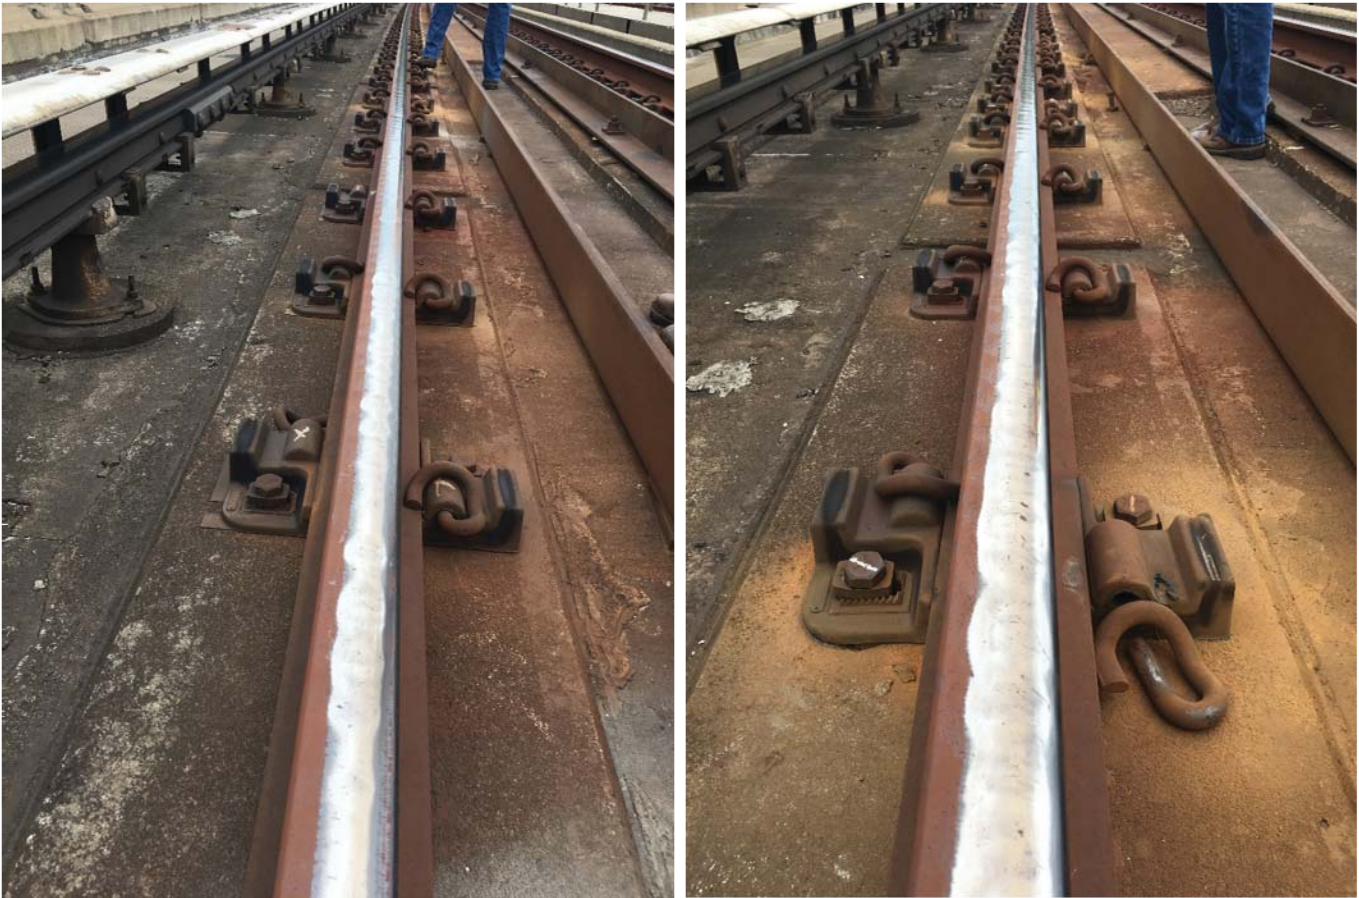
Figure 1: Rail Surface defects between F2 394+80 and 395+50.

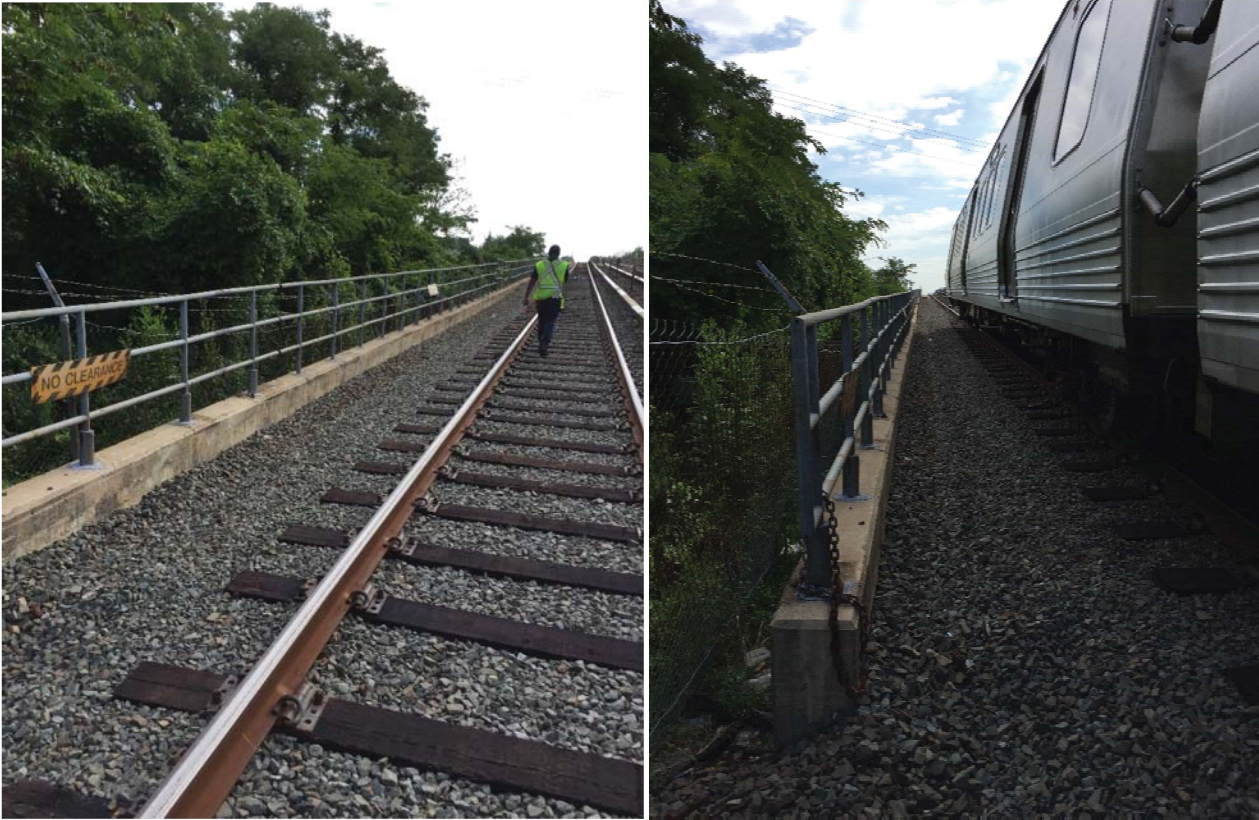
Figures 1 and 2: No clearance signage installed at J2 671+00 and a train passing this location

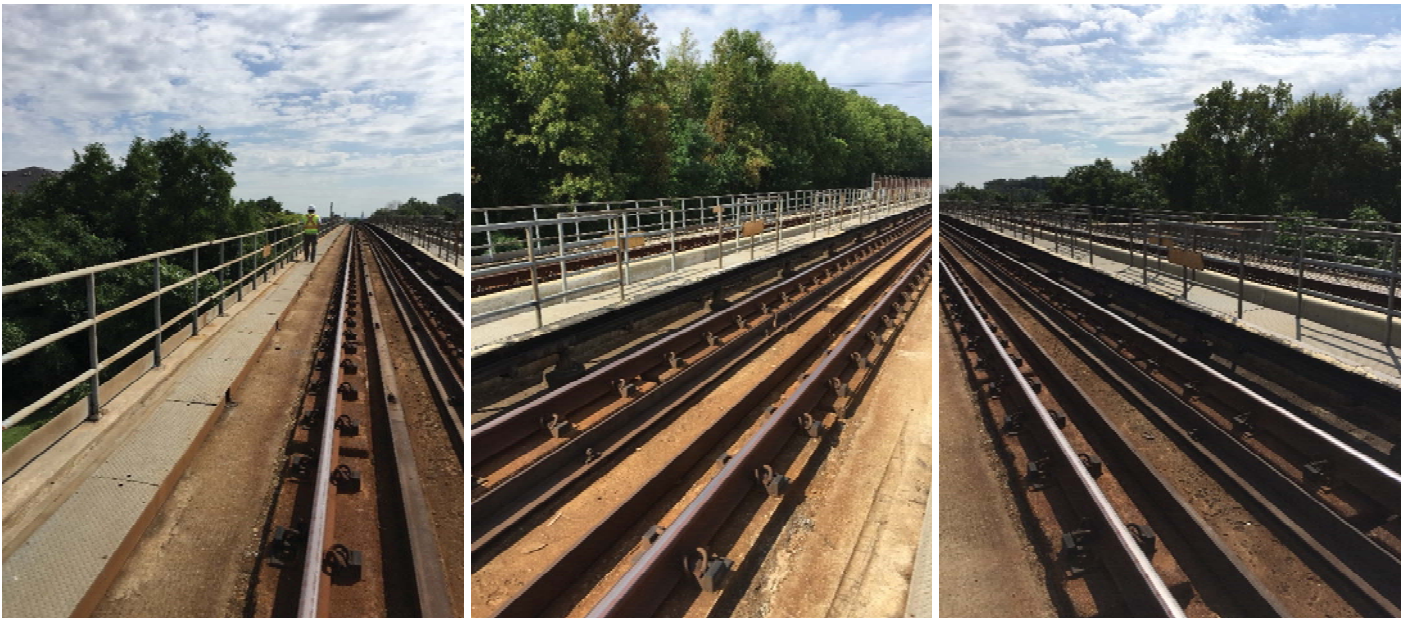
Figures 3, 4, and 5: Aerial structure at between CM 638+00 and 658+00 with no clearance signage installed on both sides

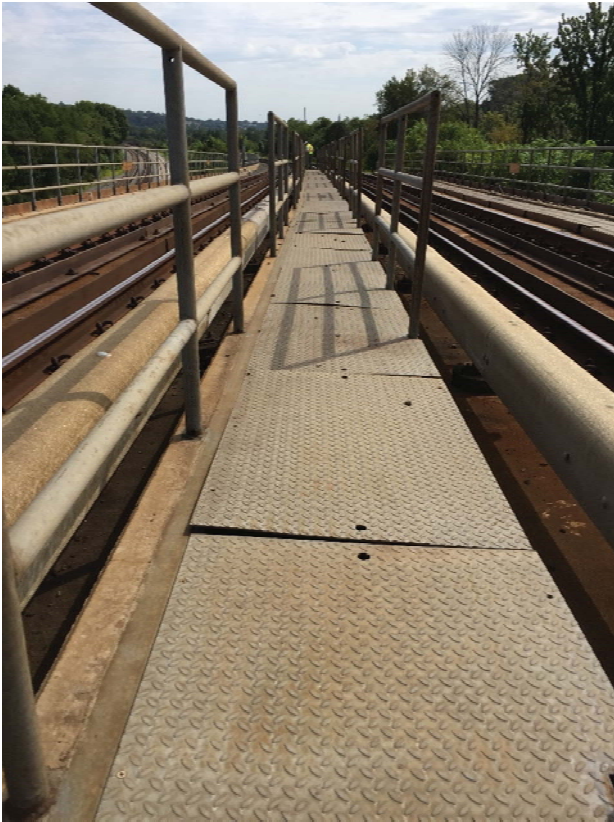
Figure 6: Loose and insecure walkway plates on the center catwalk between CM 638+00 and 658+00.

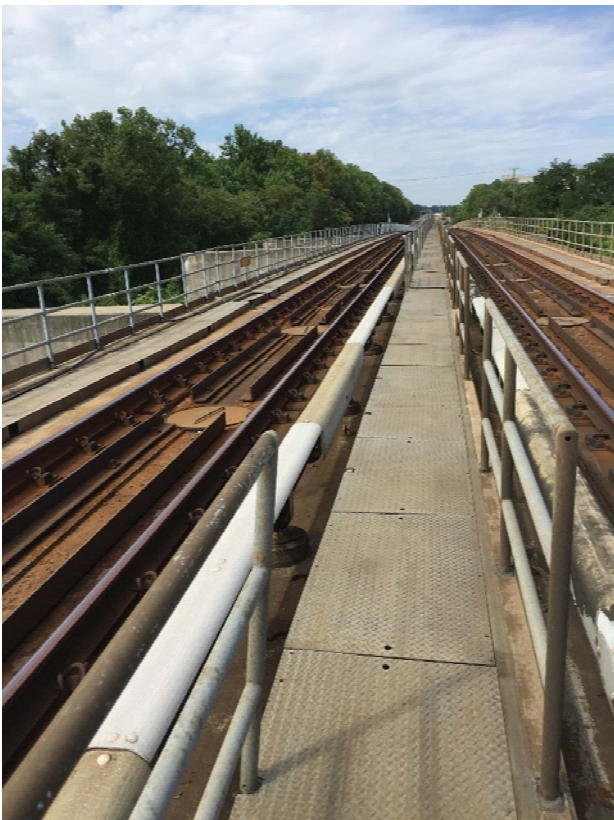
Figure 7: Missing handrail between CM 638+00 and 658+00.

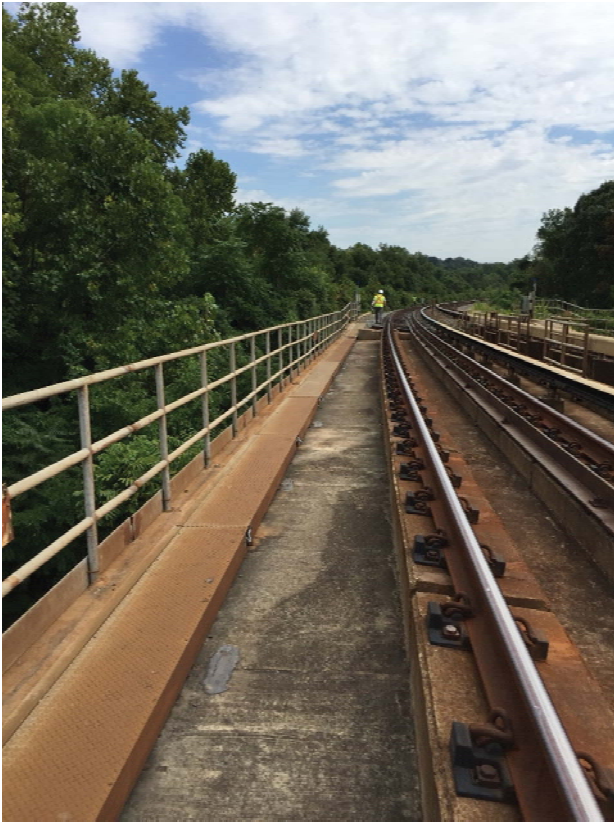
Figure 8: Aerial structure at between CM 622+00 and 628+00 with no clearance signage installed on both sides

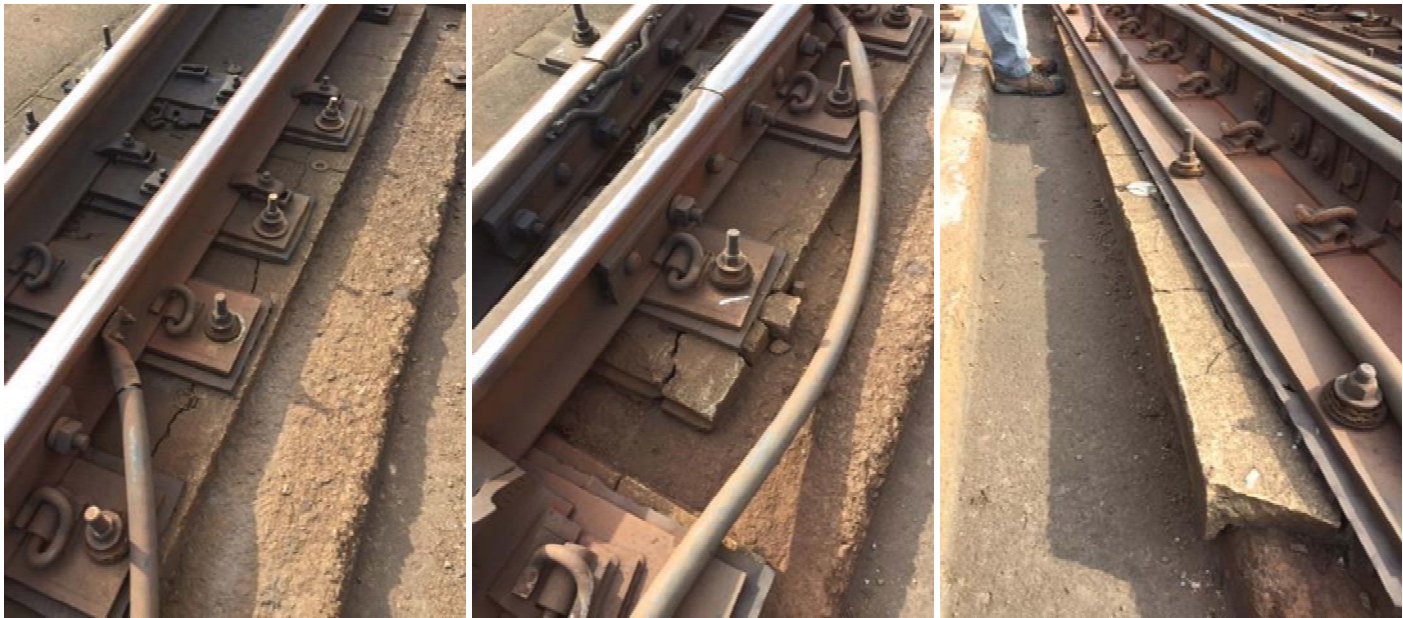
Figures 1, 2, and 3: 1B switch grout pad condition at C2 622+00

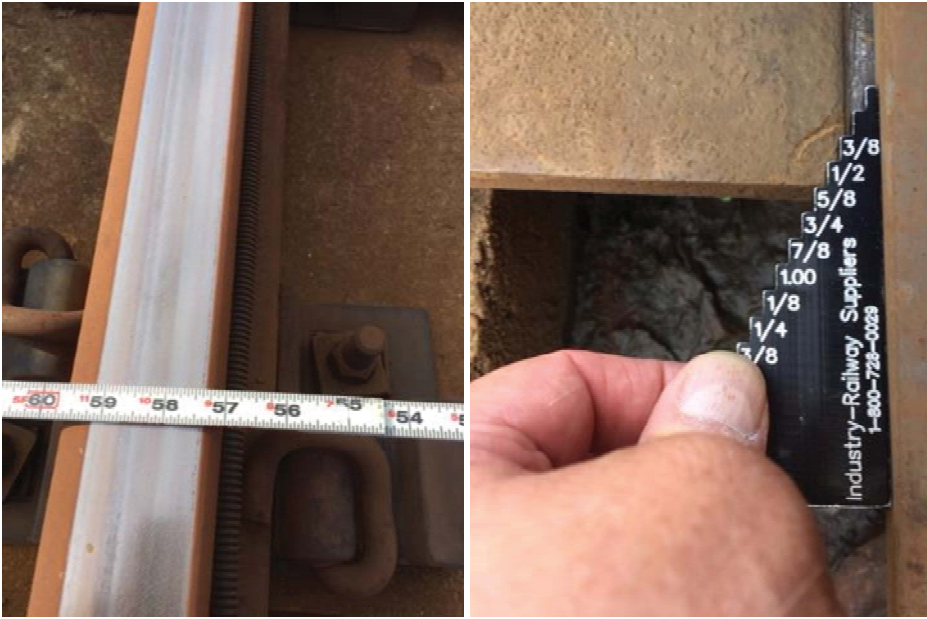
Figures 4 and 5: 1B switch 57-1/4 static gauge with 3/8-inch dynamic movement (57-5/8) at C2 622+00.

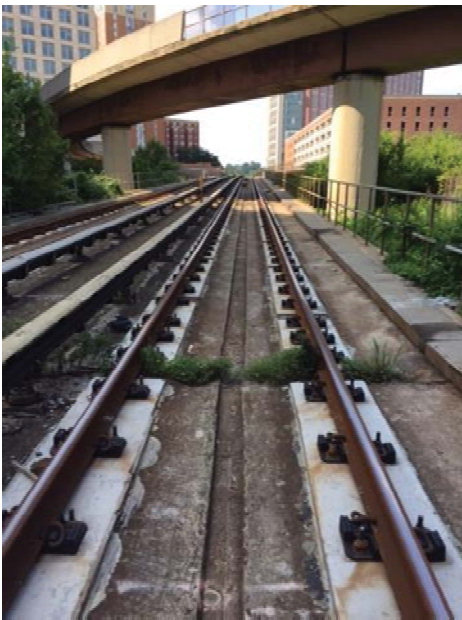
Figure 6: Gauge and third rail side vegetation between C2 583+00 and 587+00

<p>The following remedial actions were verified as complete:</p> <ul style="list-style-type: none">• Remedial Action 1280, At C2 582+50 the third rail coverboard has been replaced.• Remedial Action 1286, At C2 593+00 heat shrink tape has been installed on the conduit stub-up.• Remedial Action 1287, At C2 592+00 neat shrink tape has been installed on the conduit stub-up.• Remedial Action 1291, At C2 567+00 the third rail feeder wire has been repaired.• Remedial Action 1292, At C2 585+00 the third rail expansion cables have been moved.		
<p>Remedial Action</p>	<p>To achieve compliance with WMATA's requirements:</p> <ul style="list-style-type: none">• WMATA must repair the grout pads at C2 622+00 1B switch.• WMATA must repair the wide gauge condition at C2 622+00 1B switch.• WMATA must replace tighten the number three switch rod at C2 622+00 3B switch.• WMATA must install an end coverboard on the third rail at C2 622+20.• WMATA must install missing cover boards on track two in the station platform area.• WMATA must repair the light at the ETS box located at C2 615+00.• WMATA must remove the vegetation between C2 583+00 and 587+00.
