# LRV Bumper Safety Technology Deployment

Applied Research Associates, Inc.

U.S. Department of Transportation  
Federal Transit Administration

FTA Report No. 0247

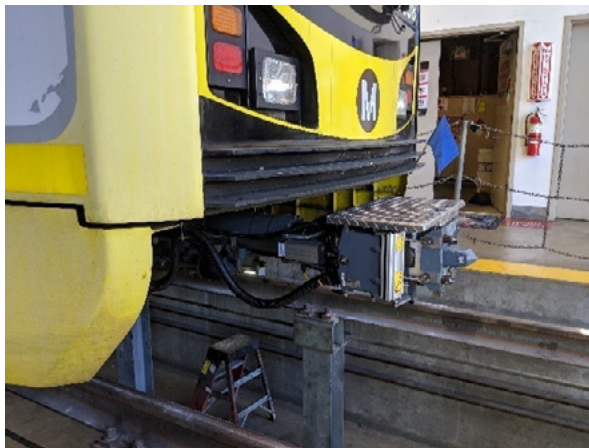
**Figure 2-1** Metro P3010 Front End

The front end of Metro's Kinkisharyo (KI) P3010 is shown in Figure 2-1. The open-ended design with the coupler protruding well ahead of the anti-climber makes the P3010 well suited for retrofit. Metro has 235 open-ended KI vehicles that have all been built since 2014. These vehicles represent a significant percentage of the Metro fleet and are newer vehicles that will remain in service for a long time. The Siemens SD660 Type 3 LRV operated by TriMet is shown in Figure 2-2. These vehicles are also operated in a shared right-of-way environment on the Blue and Yellow lines in Portland, Oregon, as shown in Figure 2-3. TriMet operates almost 62 miles of light rail service in the

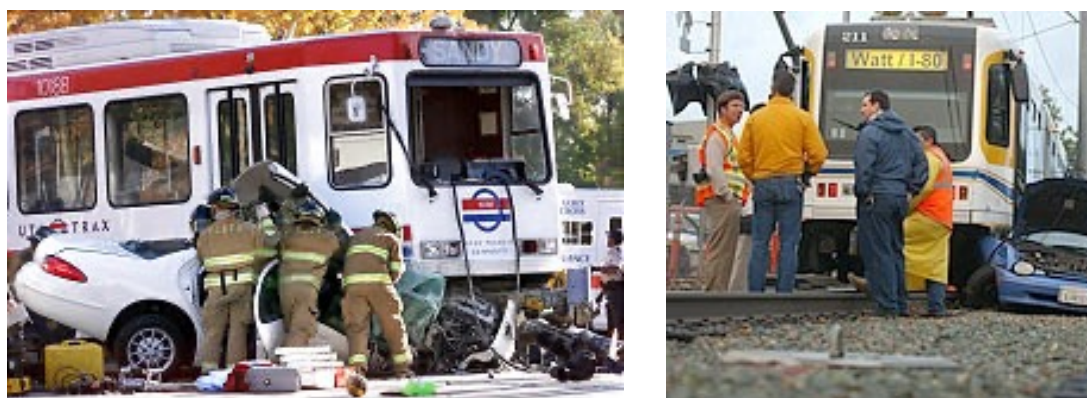
**Figure 2-4** *Example Collisions between LRV and Automobiles [6]*

These are fixed (non-retracting/folding) coupler LRVs with an open front end that has an aggressive profile when impacting automobiles. The high anti-climber and vertically sloping front-end profile have a significant potential to override automobiles in frontal collisions, as shown for other vehicles in Figure 2-4. The high anti-climber can also directly impact the automobile passengers. The fixed coupler impacts the door of the automobile in side-on crashes.

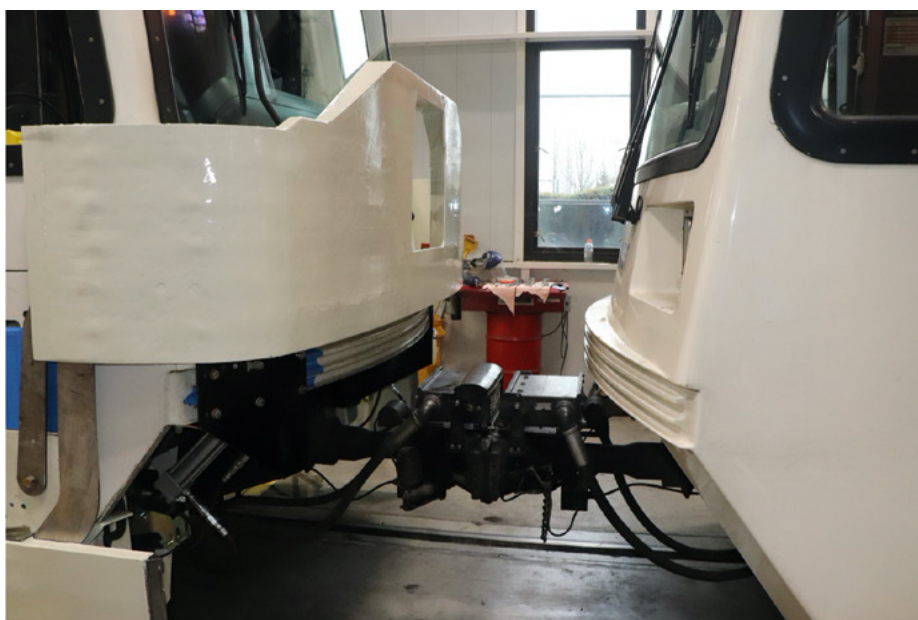
A coupling test was then performed with a second LRV, as shown in Figure 4-4. The operator in the retrofitted car noted that coupling was an easy process, and their view was not hindered by the raised enclosure. Note that the coupler cutout, needed so couplers can actuate fully during hard coupling events, also serves to provide good visibility for the operator of the coupling faces.

**Figure 4-4** Coupled Type 3 LRVs with a Temporary Front Enclosure Retrofit

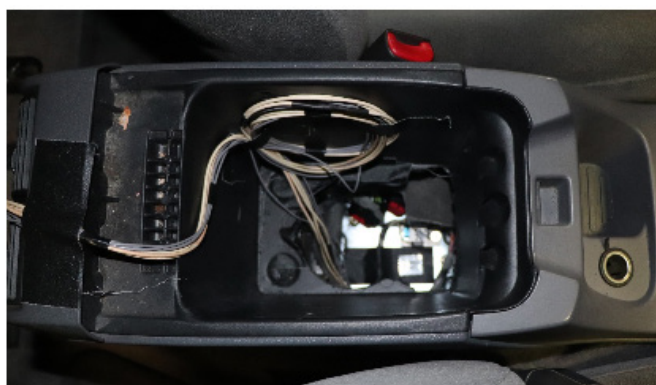
**Figure 5-8** *Test 1 Accelerometers Mounted at the Base of the Center Console*

Triaxial accelerometers were positioned at the longitudinal CG of the automobile to measure translational and rotational accelerations. These are shown mounted at the base of the center console in Figure 5-8. Load cells were mounted between the test article and the mounting frame to measure the reaction load at the barrier wall, as shown in Figure 5-9. Specific load cell instrumentation was provided, shown in Figure 5-4. Two (2) laser speed traps were used to measure the impact speed. These traps measure the time between interruption of the laser as they crossed forks mounted to the vehicle roof, as shown in Figure 5-10. Tape contact switches were attached to the front enclosure to trigger and synchronize the data acquisition equipment, as shown in Figure 5-11. High-speed photography was taken at overhead, left/right sides, and beneath the test article to view the side panels, as shown in Figure 5-12.

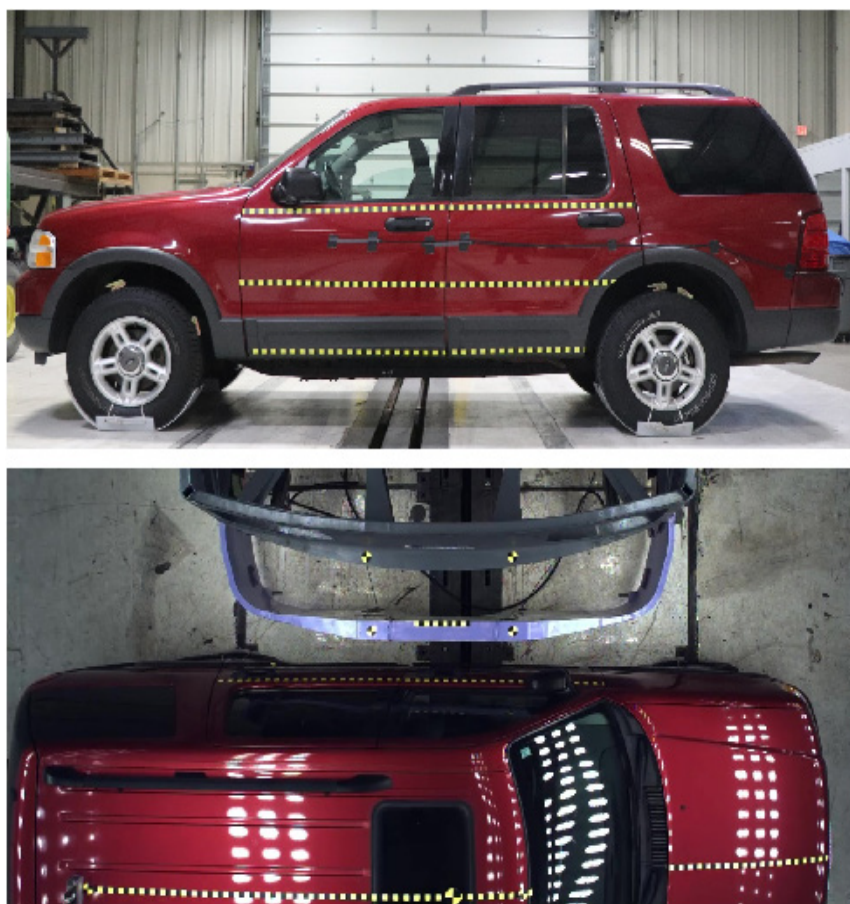
**Figure 5-14** Markers on the Exterior of the 2003 Explorer in Test 1

Markers (quad targets and inch tape) were positioned on the LRV test article and the automobile, as shown in Figure 5-13 to Figure 5-15. The markers on the test article (Figure 5-13) were placed on both sides, and positions from the wall and the ground were documented. The inch tape was positioned at three heights on the impact side of the Explorer (Figure 5-14) to measure the geometry before and after the test. Markers were also placed on each B-pillar at 4-inch spacing to measure pillar deformation into the occupant compartment.

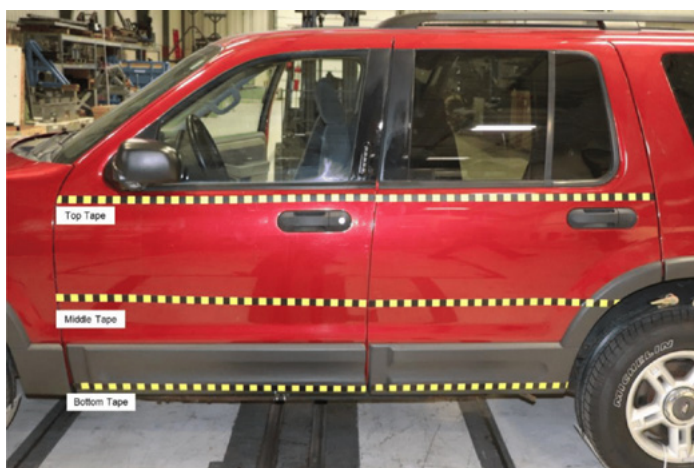
**Figure 5-34** *Location of Inch Tape on the 2003 Ford Explorer (pre-test)*

Surface profile data of the front and rear driver side doors were measured before and after the test. This was accomplished by placing inch tape across both doors at three different heights, as seen in Figure 5-34. Using a Leica Disto laser measurement tool, distance data were collected every 6-inches along the inch tape with reference to a planar surface. Figure 5-35 shows the location at which the laser was directed while maintaining perpendicularity to the plane, both vertically and horizontally. Deformation on the impact side of the Explorer post-test is shown in Figure 5-36.

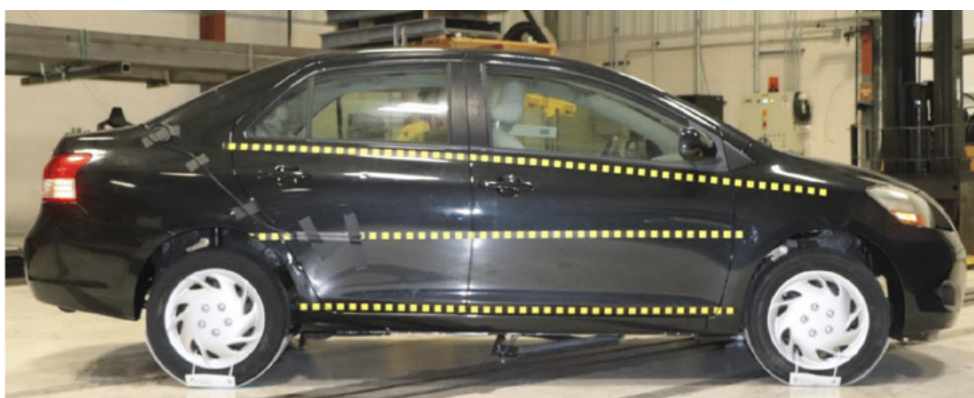
**Figure 5-45** Location of Inch Tape on the 2010 Toyota Yaris (pre-test)

Surface profile data of the front and rear driver side doors were measured before and after the test. This was accomplished by placing inch tape across both doors at three different heights, as seen in Figure 5-45. Using a Leica Disto laser measurement tool, distance data were collected every 6 inches along the inch tape with reference to a planar surface. Deformation on the impact side of the Yaris post-test is shown in Figure 5-46.

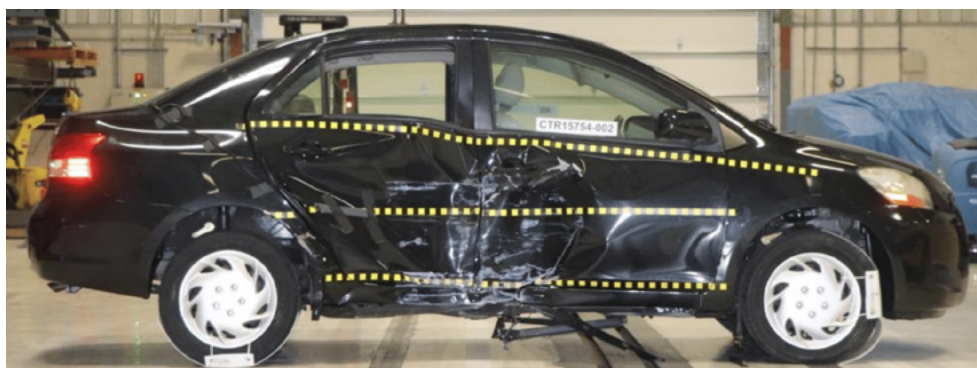
**Figure 5-46** Impact Damage to the Yaris in Test 2 Where Inch Tape Measurements Were Made

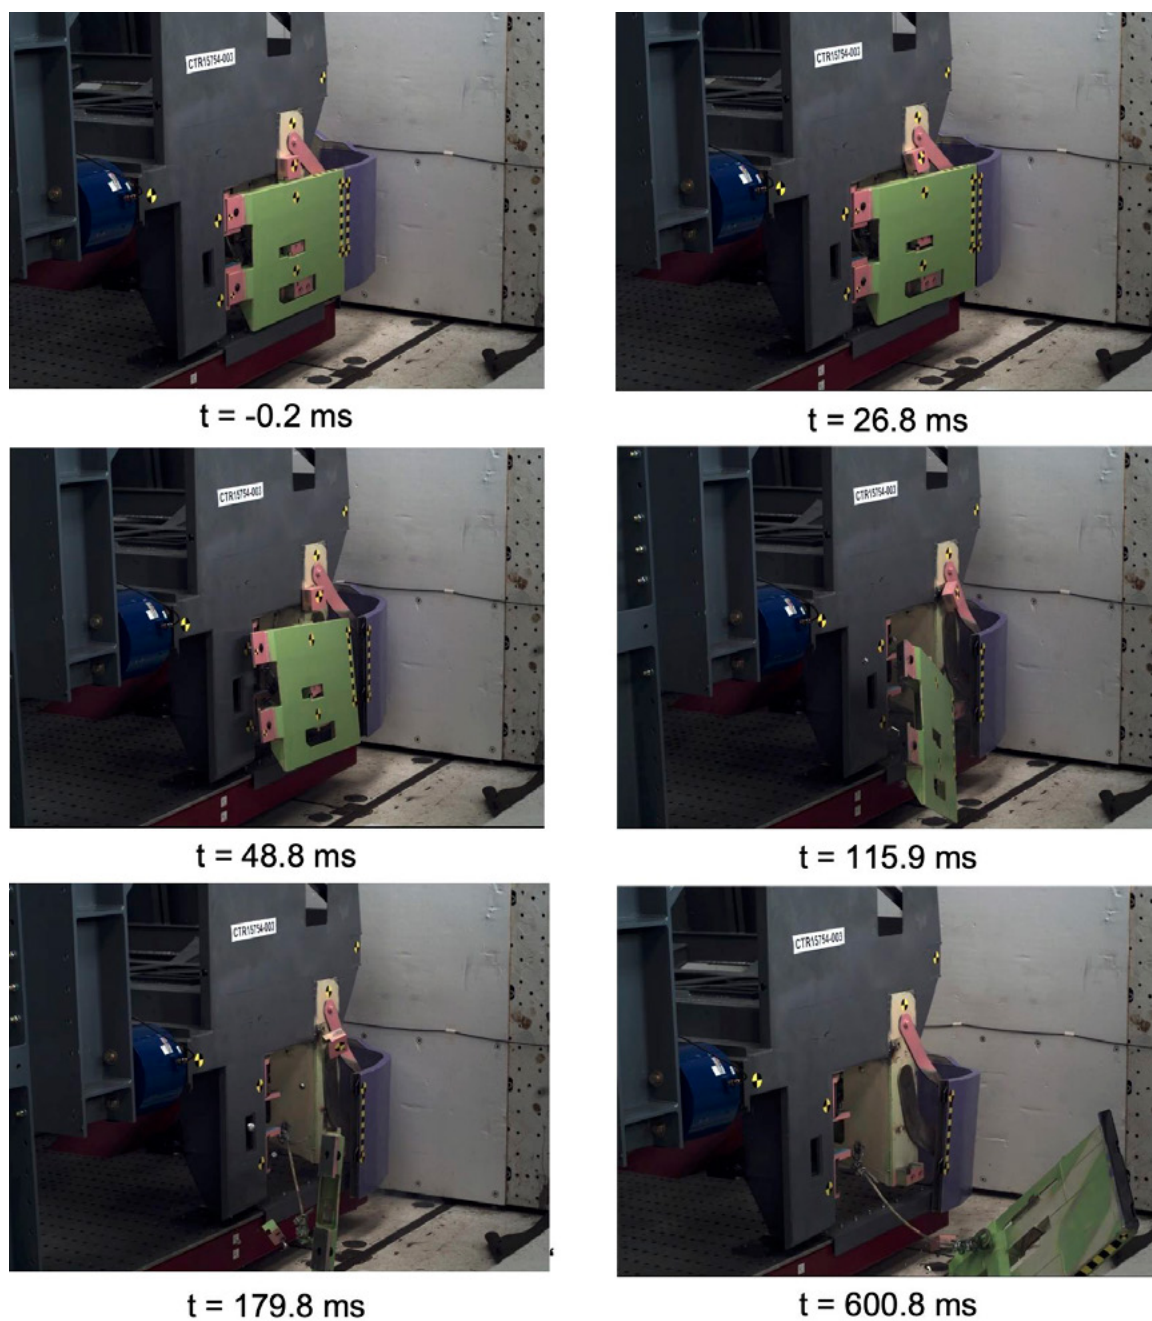
**Figure 5-53** High-Speed Video (right) of Test 3

**Figure 5-54** High-Speed Video (left) of Test 3

**Figure 5-55** High-Speed Video (right-oblique) of Test 3

The test sled in its final resting position is shown in Figure 5-57. The front enclosure remained attached to the upper linkage arms, which bent backward but did not separate. There was no damage to the carbody of the SD660 end frame or the linkage mounts due to the crash loads and they are completely reusable. The gas springs and hydraulic cylinders remained attached to their anchored locations and the swivel arm. Return to service would require replacing the linkage arms, new or refurbished side panels, and a new or refurbished front-end enclosure.

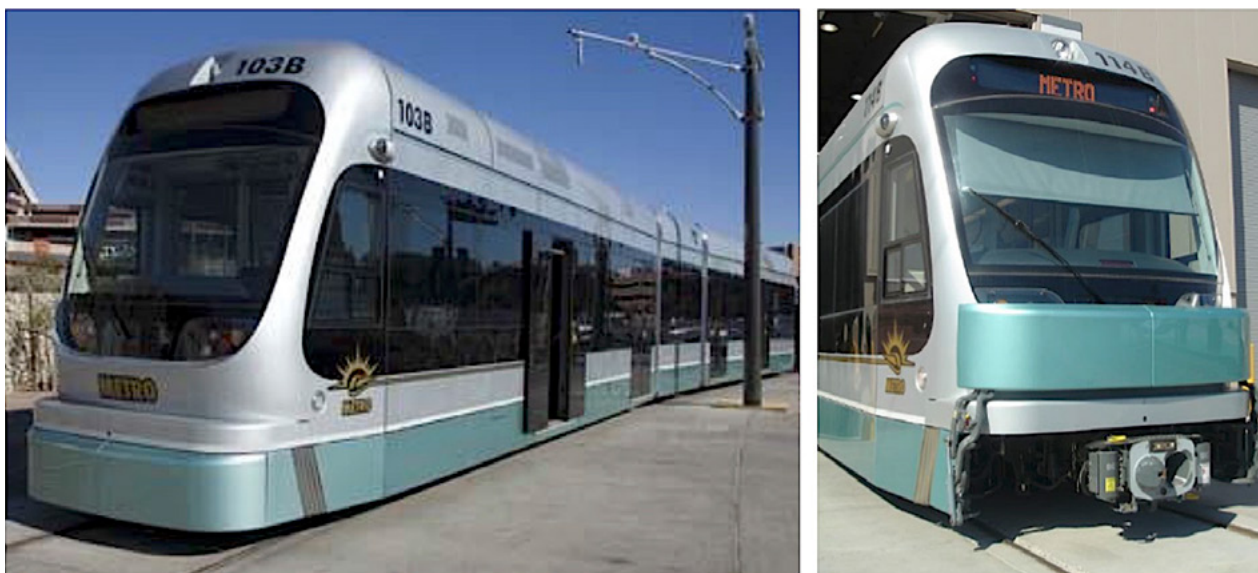
**Figure 6-1** Kinkisharyo Low Floor LRV with a Front Enclosure [8]

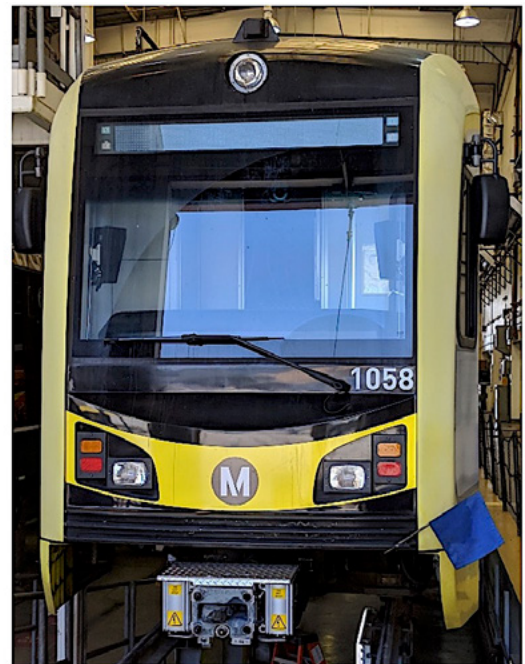
There are three main components to the retrofit: (1) the retractable front enclosure, (2) a breakaway side panel, and (3) mechanical linkage to connect them. The geometry conforms tightly to the cab profile when in the retracted state and minimizes the profile ahead of the coupler with a broad engagement area to improve crash energy management. Note that in the retracted position the operator window is not obstructed, and the anti-climbers are clear to engage. The retrofit is performed by removing the existing side panels shown in Figure B-4 and replacing them with the breakaway structural side panel. The breakaway connections have not yet been designed for this vehicle.
