Inspection Form

Form FTA-IR-1

United States Department of Transportation
Federal Transit Administration

Inspection Date	YYYY	MM	DD	Report Number	20180402-WMATA-WP-1		
	2018	04	02				
Rail Agency Name	Washington Metropolitan Area Transit Authority			Rail Agency Department	TRPM	Sub-Department	
Rail Agency Department Contact Information	Name		Email		Office Phone		Mobile Phone
	[REDACTED]		[REDACTED]		[REDACTED]		[REDACTED]
	[REDACTED]		[REDACTED]		[REDACTED]		[REDACTED]
Inspection Location	B-Line, Judiciary Square (B02) – Tie Breaker Station (TBS)

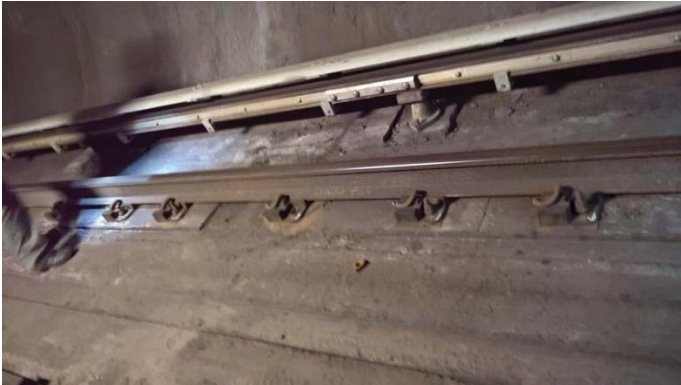
Figure 1: Fasteners at CM A1 462+10 to CM A1 462+25.

<ul style="list-style-type: none">• Tunnel leak was repaired and cleaned up at A1 455+00.• Tunnel leak was repaired and cleaned up at A1 487+00.• Tunnel leak was repaired and cleaned up at A1 499+50.• WMATA has repaired ETS box door at A1 534+00.		
Remedial Action	To achieve compliance with WMATA's requirements: <ul style="list-style-type: none">• WMATA must tighten down and repair fasteners at CM A1 462+10 to CM A1 462+25.• WMATA must repair third rail anchor arm at CM A1 442+10.• WMATA must tighten #3 and #4 switch rods in switch 1A CM A1 443+20.

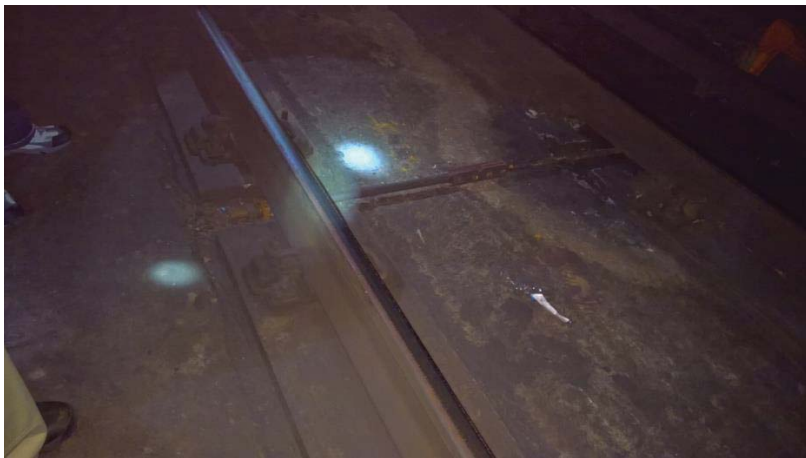
Figure 1: Gauge rod at CM G2 449+40.

<p>Other notable observations:</p> <ul style="list-style-type: none">• FWSO inspector observed seven gauge rods between Benning Road (G01) and Capital Heights (G02) install, securing three color coded defects. Inspector verified with WMATA that defects were in their data base and active.• FWSO inspector observed four gauge rods between Capital Heights (G02) and Addison Road (G03) install, securing two color coded defects. Inspector verified with WMATA that defects were in their data base and active. One of the gauge rods at CM G2 449+00 had come loose and fallen off, and a WMATA Supervisor was notified. A work crew re-installed at 0233. See Figure 1 below.		
<p>Remedial Action</p>	<p>To achieve compliance with WMATA's requirements:</p> <ul style="list-style-type: none">• WMATA must remove relay rail from CM G2 347+40 to CM G2 354+90.• WMATA must remove relay rail from CM G2 361+10 to CM G2 360+00.• WMATA must repair tunnel leak over catwalk at CM G2 424+00.• WMATA must remove relay rail from CM G2 465+30 to CM G2 466+90.

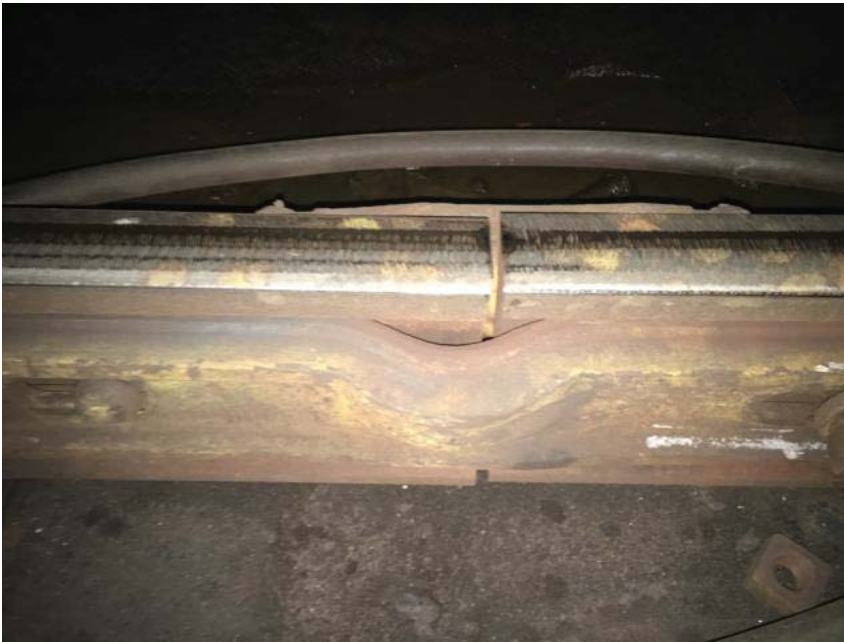
Figure 1: Improper joint bar was installed at the rail joint, right rail at 105+00. These bars are not designed to provide the same structural contact fitting into the web with contact along all sides of the base and underside of the ball. These are also designed with slotted bolt holes allowing excessive movement which affect RNT and opens the joint producing significant impact. They don't restrain the rail since the joint can open 2 inches as the bolt slides through the slots. They are designed to give additional protection to a field weld so if it breaks the rails stay lined up.

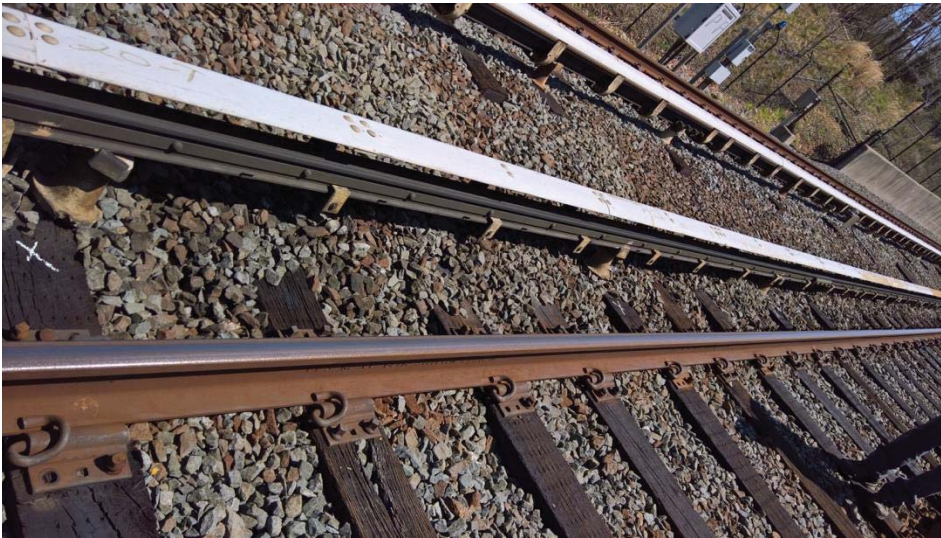
Figure 1: Third rail insulators at CM F2 427+50 to CM F2 428+50.

<p>The following remedial actions were verified as complete:</p> <ul style="list-style-type: none">• WMATA corrected clearance issue with orange boot power assembly at CM F2 383+00.• WMATA replaced rail between CM F2 394+80 to CM F2 395+50.• WMATA has replaced broken orange boot power assembly at CM F2 398+00.• WMATA has secured third rail expansion cables at CM F2 407+70.		
<p>Remedial Action</p>	<p>To achieve compliance with WMATA's requirements:</p> <ul style="list-style-type: none">• WMATA must replace coverboard end cover at CM F2 535+00.• WMATA must remove relay rail at CM F2 501+50 to CM F2 497+90.• WMATA must remove relay rail at CM F2 487+30 to CM F2 482+00.• WMATA must repair third rail anchor arm at CM F2 480+50.• WMATA must replace coverboard end cover at CM F2 397+50.• WMATA remove relay rail at CM F2 389+30 to CM F2 385+50.

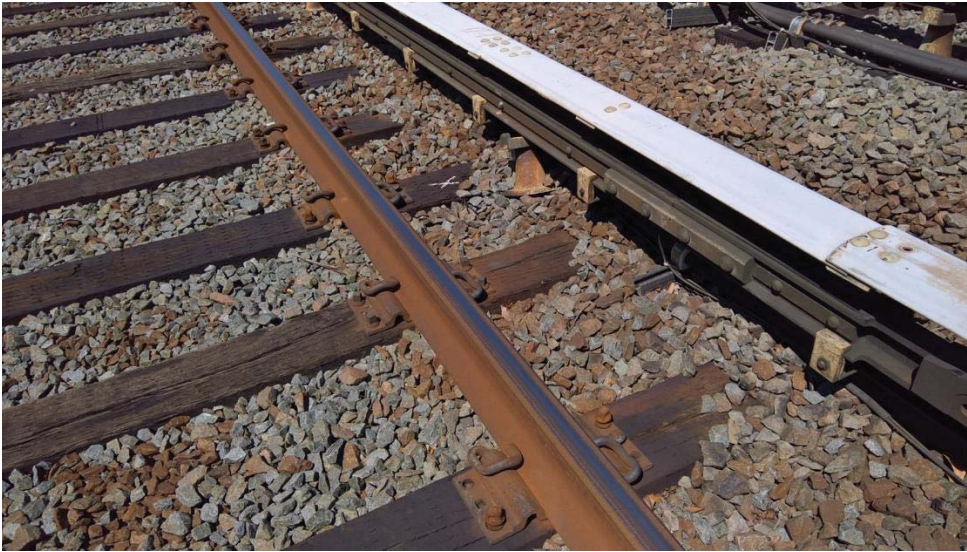
Figure 2: Third rail insulators at CM F2 427+50 to CM F2 428+50.

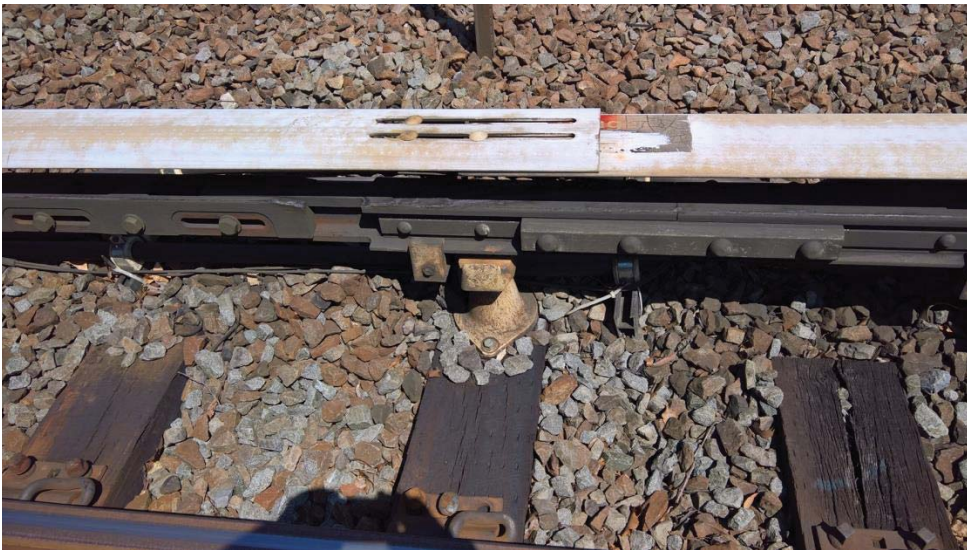
Figure 3: Third rail insulators at CM F2 427+50 to CM F2 428+50.

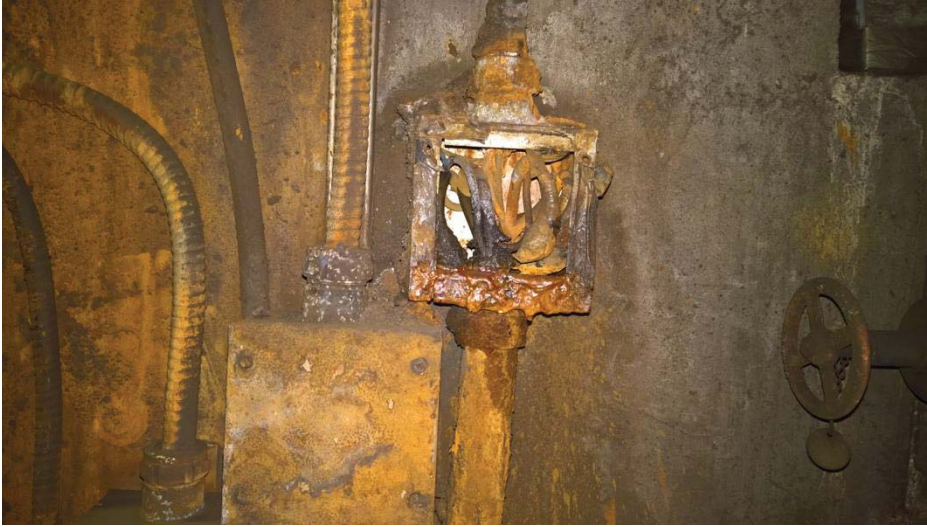
Figure 1: CM 249+30 tunnel leak through electric box.

Recommended Finding?	No			
								Remedial Action Required?	Yes			
								Recommended Reinspection?	Yes			
Remedial Action	<p>To achieve compliance with WMATA's requirements:</p> <ul style="list-style-type: none"> ● WMATA must repair tunnel leak over cat walk at CM F2 249+30. ● WMATA must replace third rail coverboard at CM F2 169+70 to CM F2 170+10.

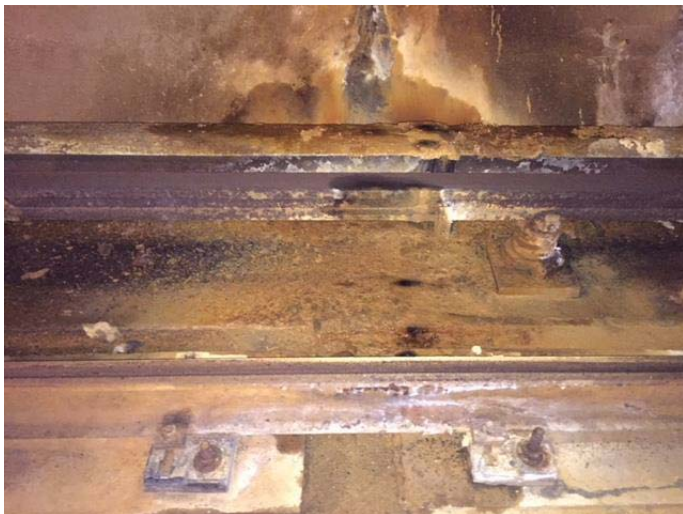
Figure 1: Sidewall tunnel leak at CM C1 635+00.

Recommended Finding?		No		
								Remedial Action Required?		Yes		
								Recommended Reinspection?		Yes		
Remedial Action	To achieve compliance with WMATA standards: <ul style="list-style-type: none"> WMATA must repair the tunnel leak and access the third rail, running rail, and fasteners at C1 635+00.

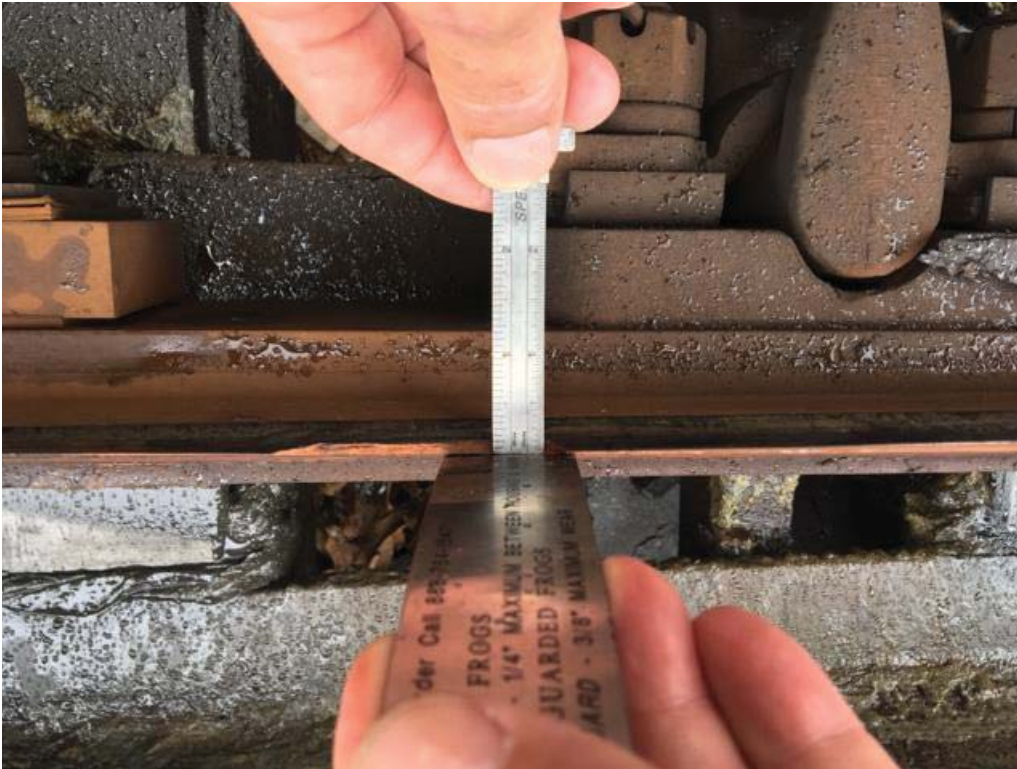
Figure 1: Chipped Point (Width 1/8") Right hand point, turnout side 1A switch at J1 874+00.

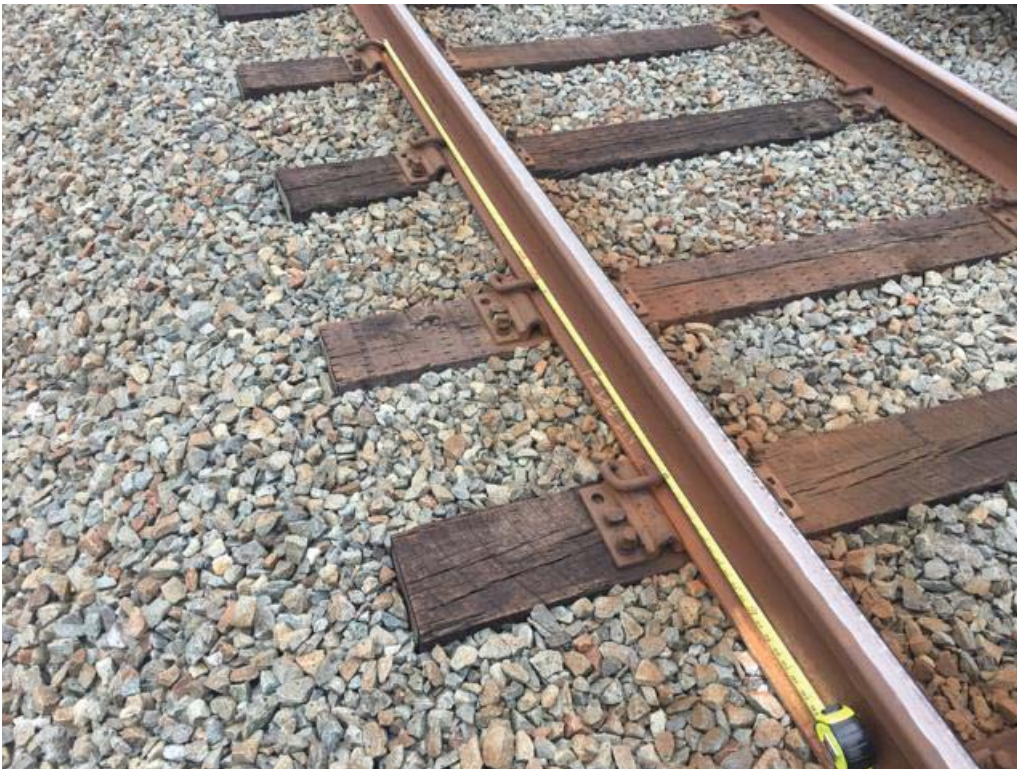
Figure 2: Non-Testable Rail, right rail eight feet in length at J1 856+50.

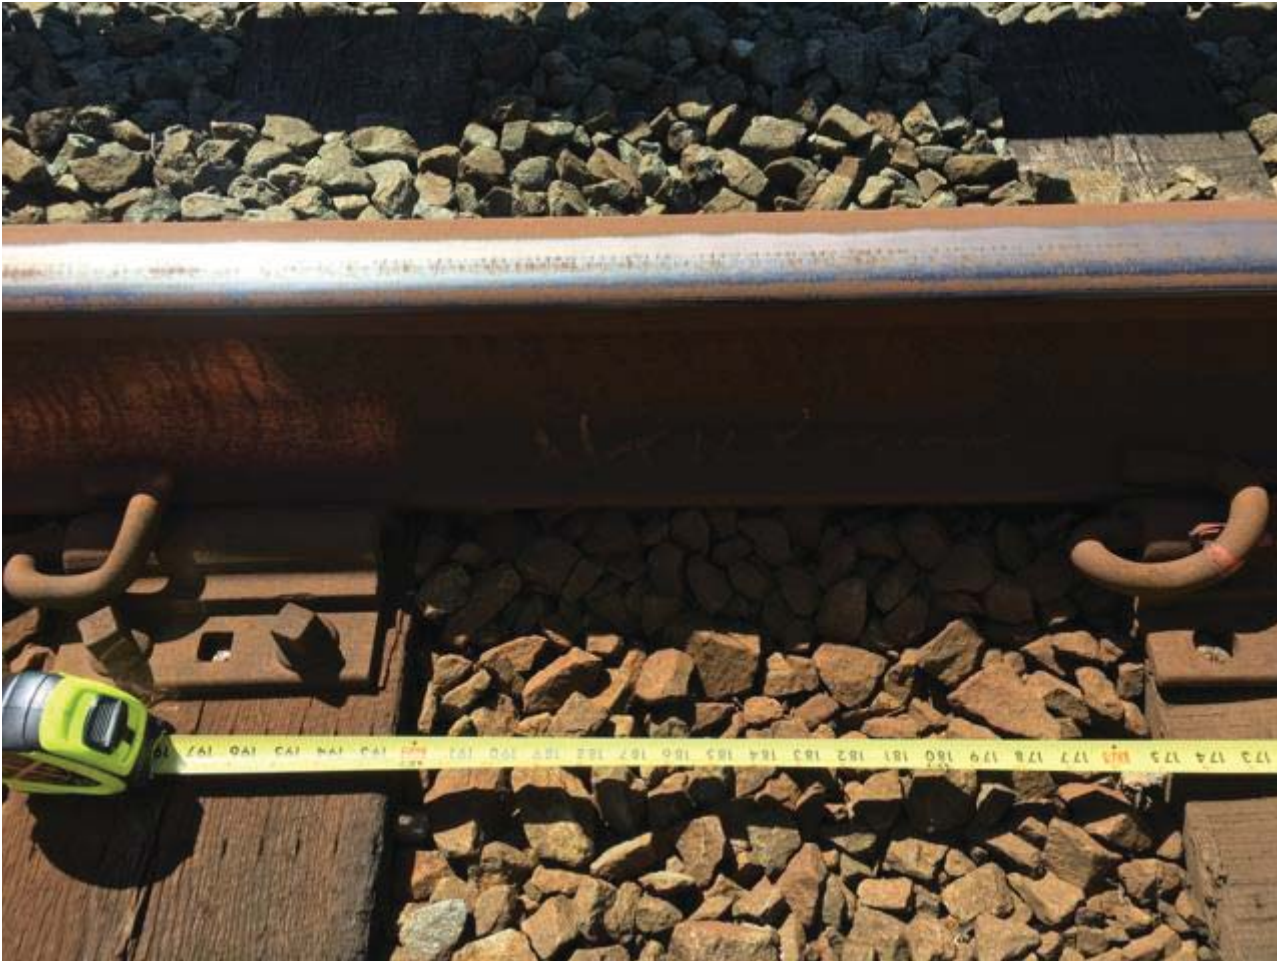
Figure 1: Non-Testable Rail, sixteen feet in length, left rail and high rail of curve at 689+50.

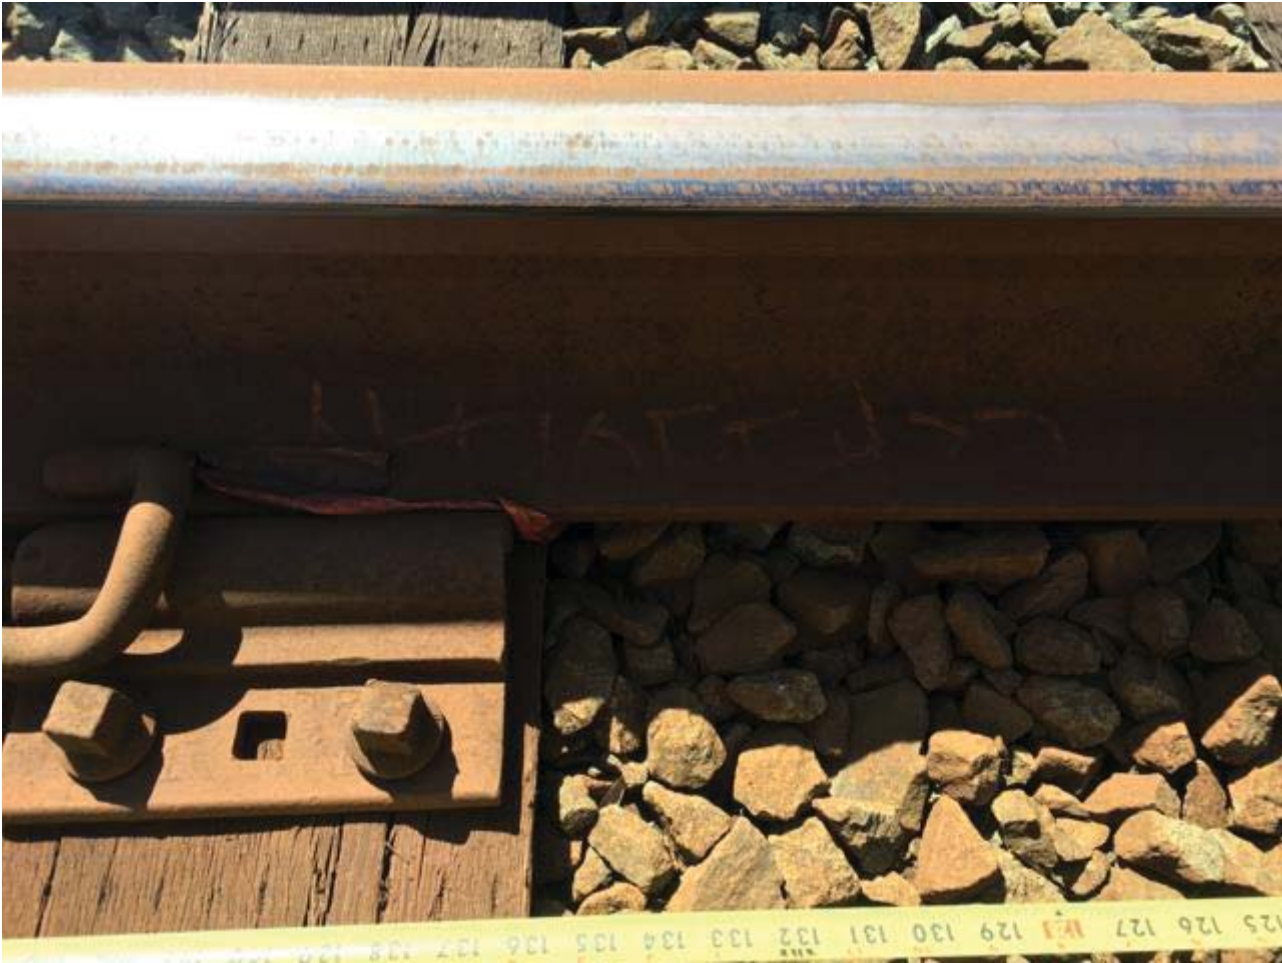
Figure 2: Non-Testable Rail, left rail and high rail of curve at 687+80.
