**Inspection Form**  
FOIA Exemption: All (b)(6)

**Form FTA-IR-1**

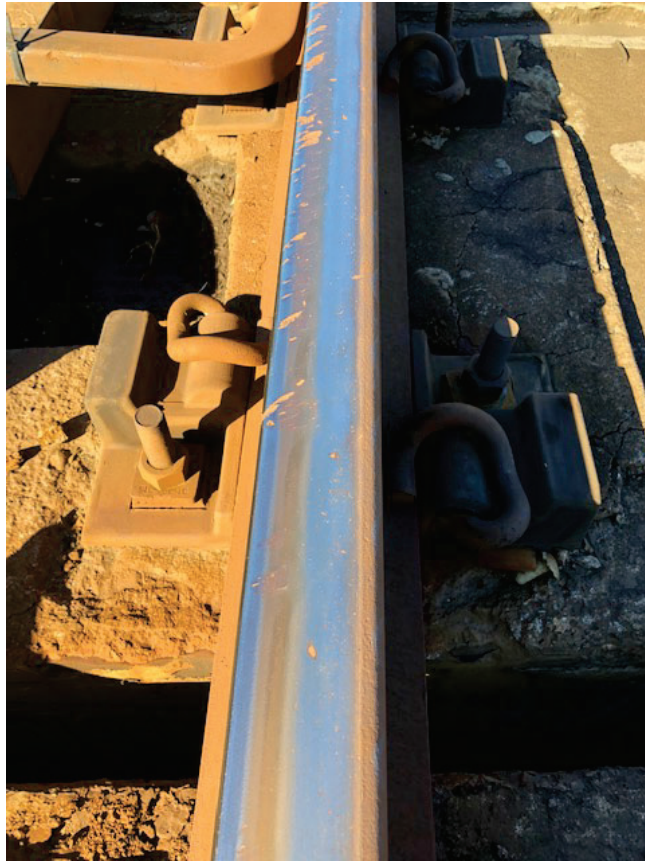
Figure 2: Rail spalling at D1 272+00.

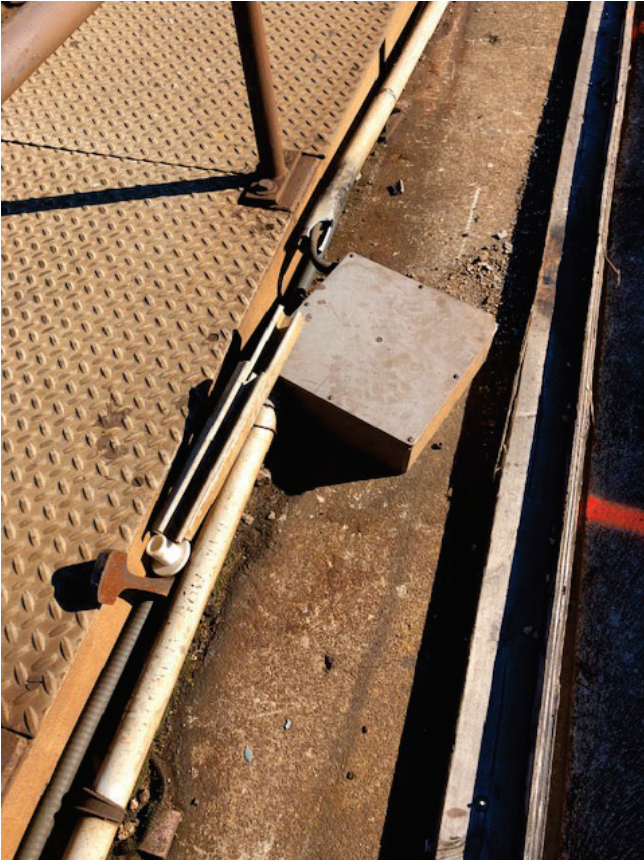
Figure 3: Dislodged electrical junction box at D1 261+40.

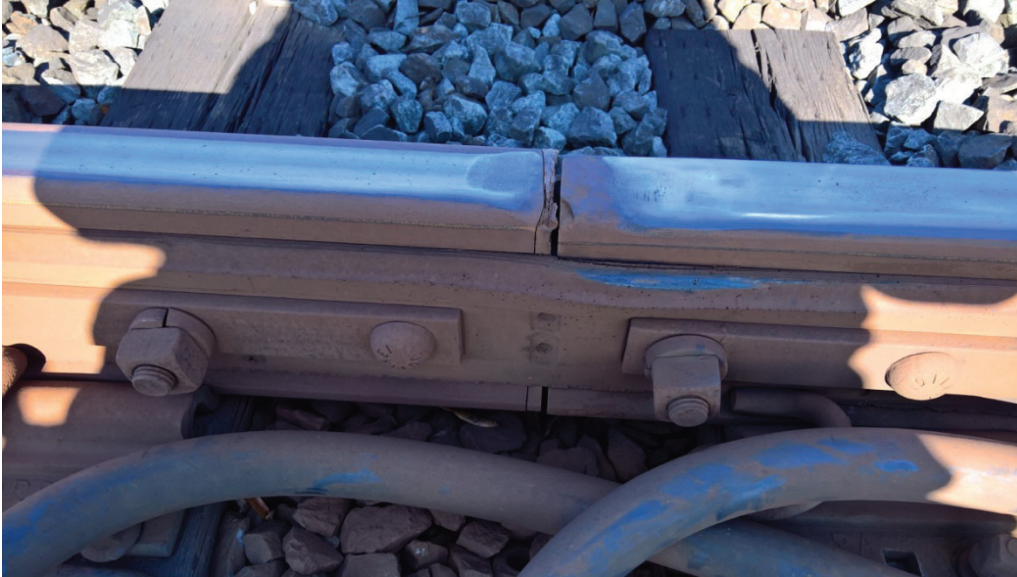
Figure 1: Insulated Joint at CM K1 772+20.

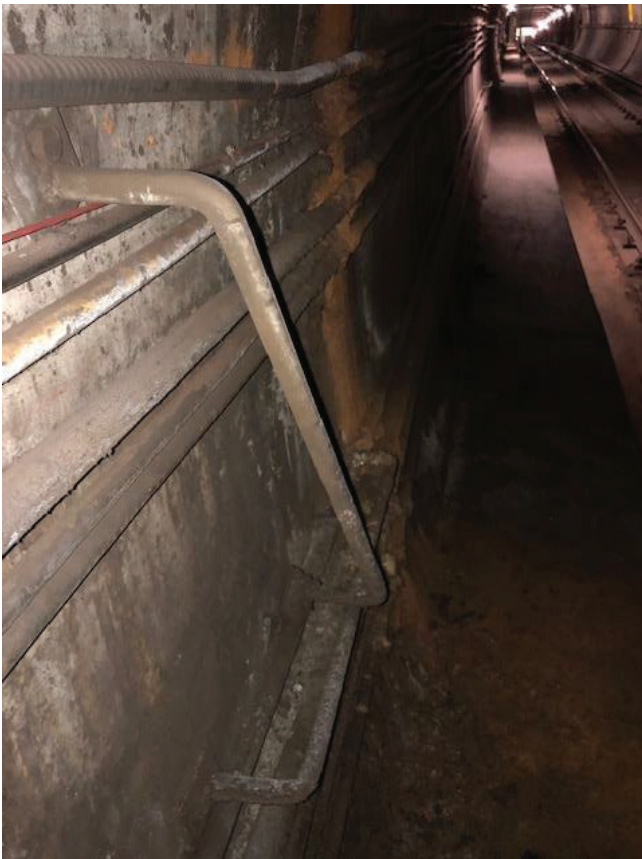
**Figure 1:** Dislodged hand railing at F2 038+00.

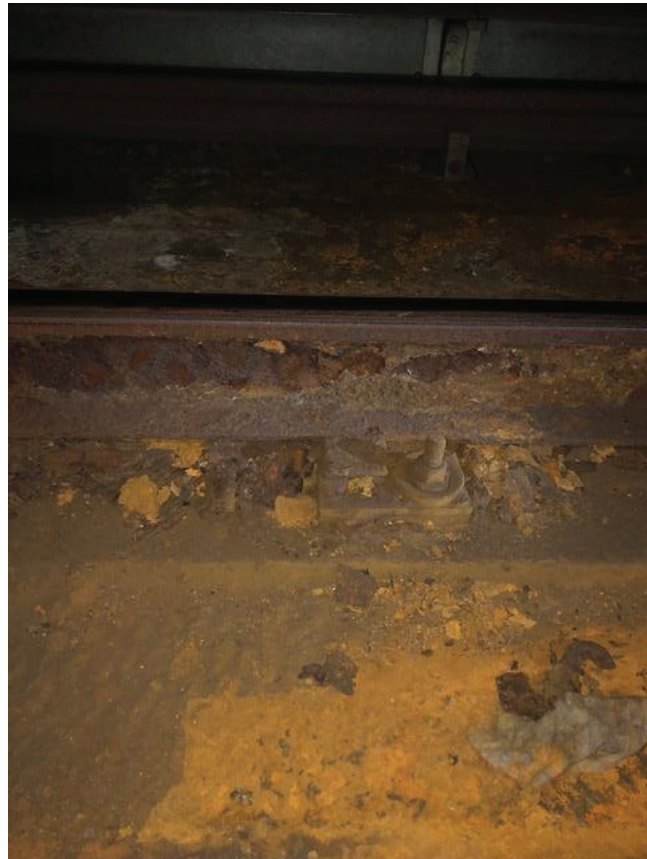
**Figure 2:** Web corrosion on the right rail at F2 035+35.

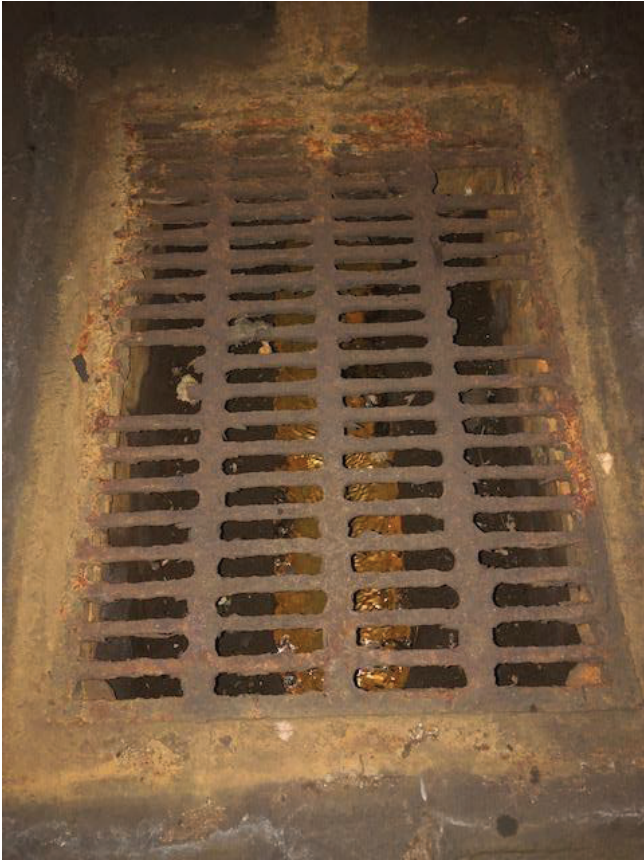
**Figure 3:** Deteriorated and corroded center drain at F2 033+25.

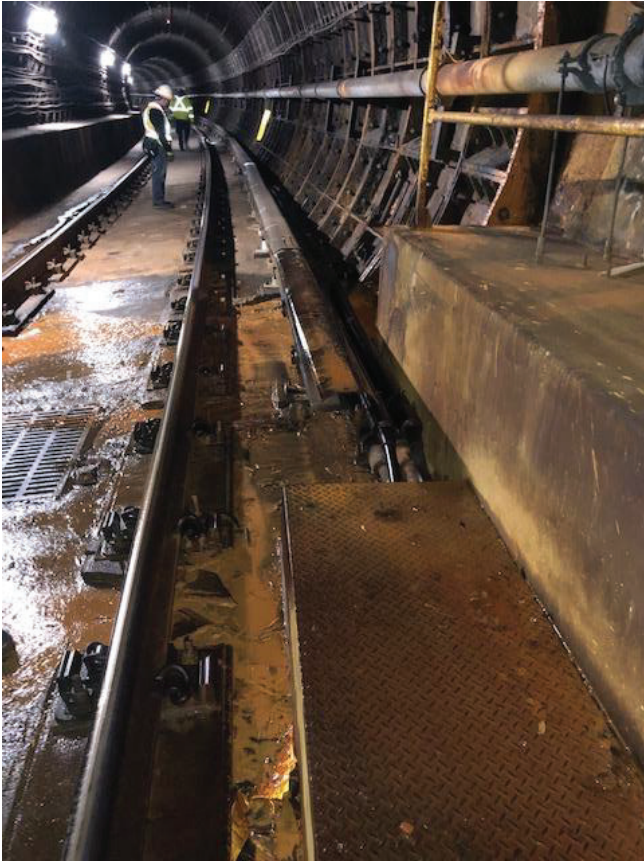
Figure 1: Tunnel leak at L2 070+60.
