Inspection Form
FOIA Exemption: All (b)(6)

Form FTA-IR-1

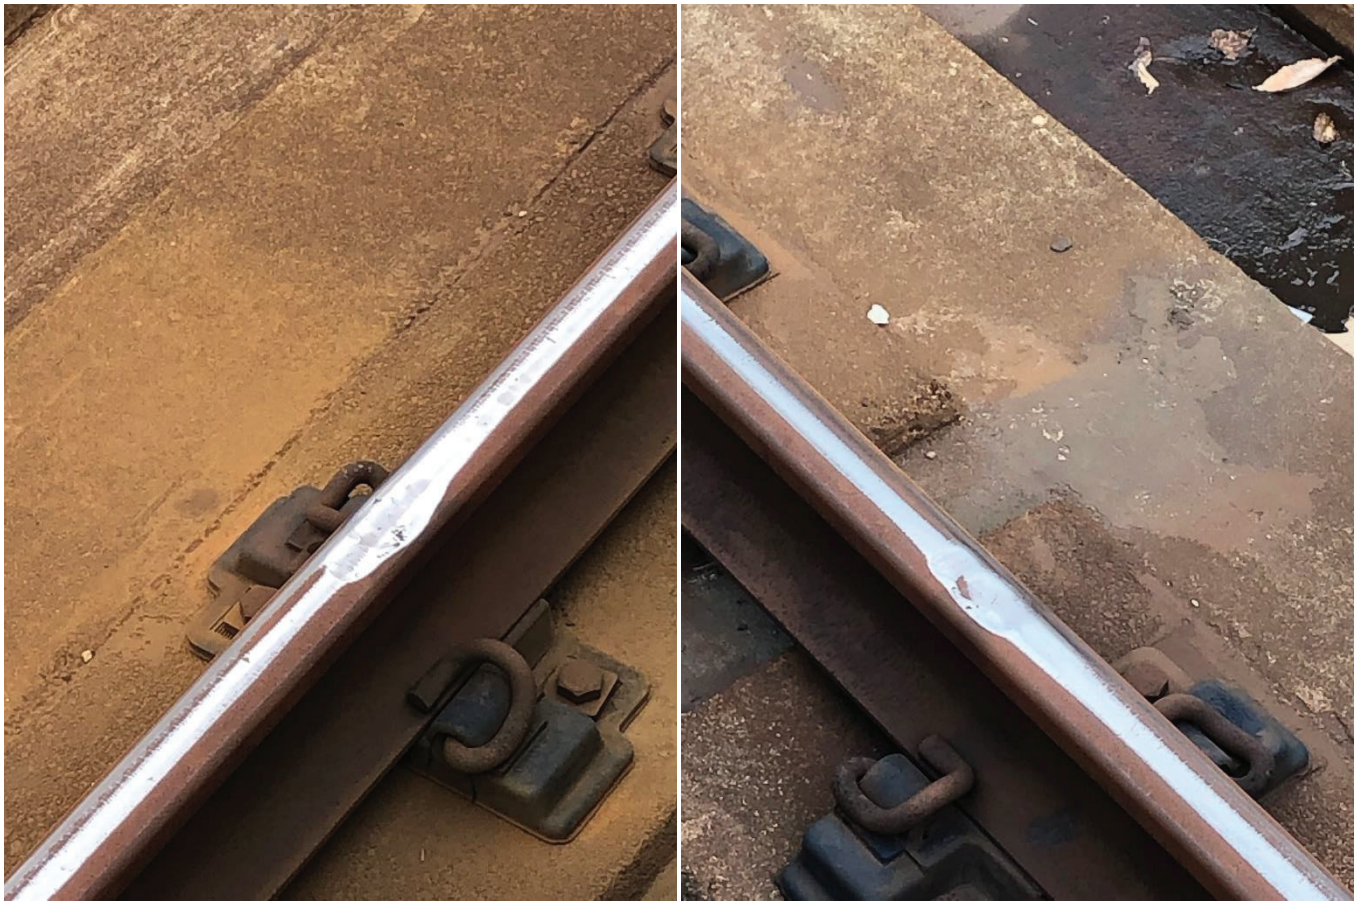
Figures 1 and 2: Engine burns near the 6-car marker on the right rail of track 2 at the West Hyattsville station.

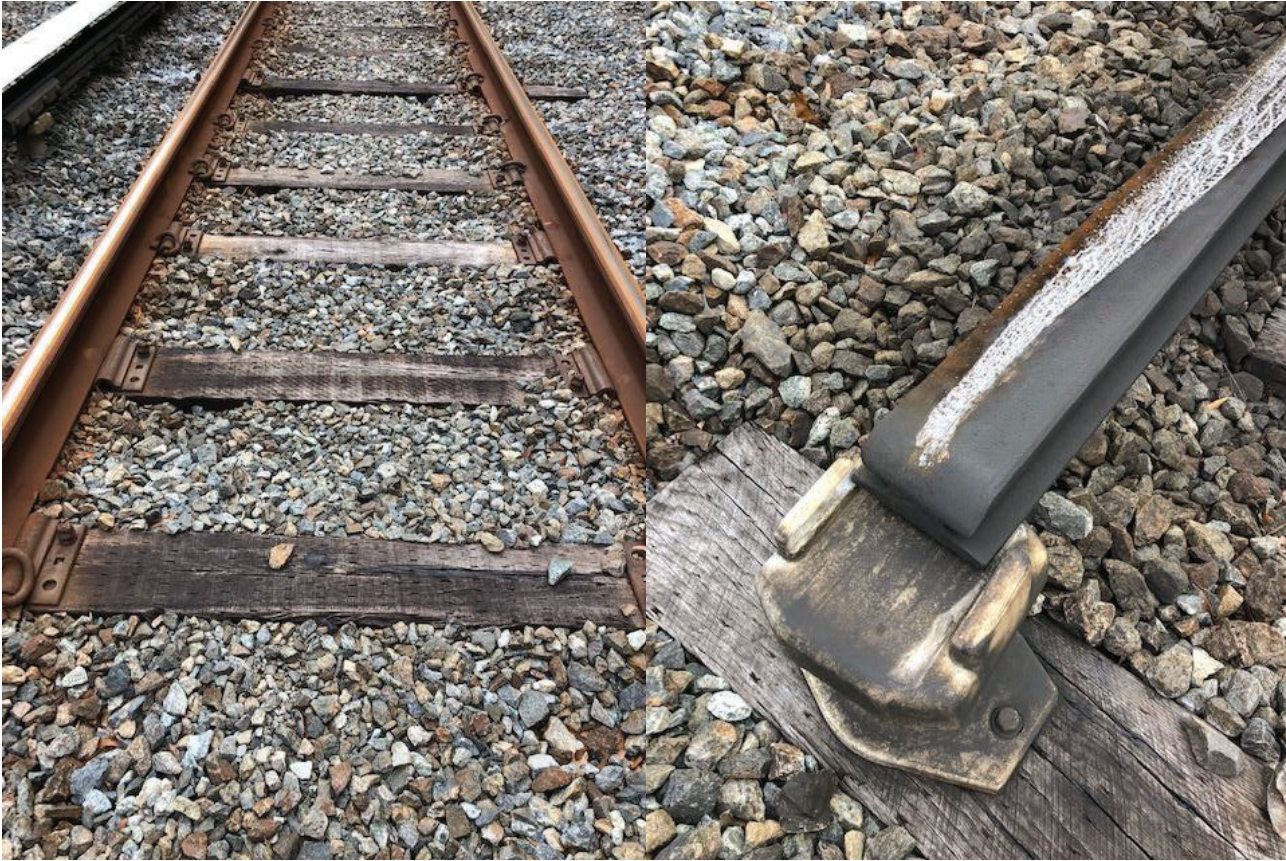
Figure 1: At A1 786+65, missing pandroll clips.

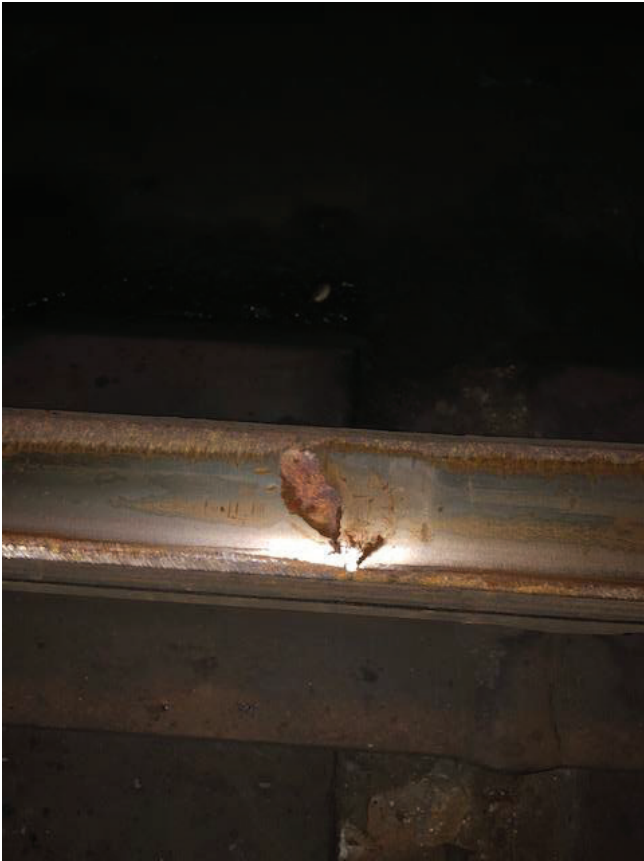
Figure 1: At D1 0085+85, on the right rail a chipped condition was observed.

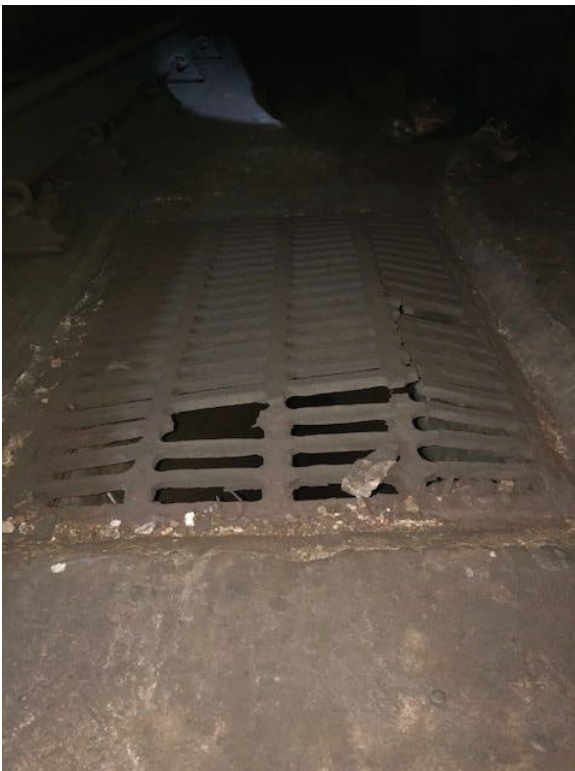
Figure 2: Center drain corroded and bent upwards at G1 449+30.

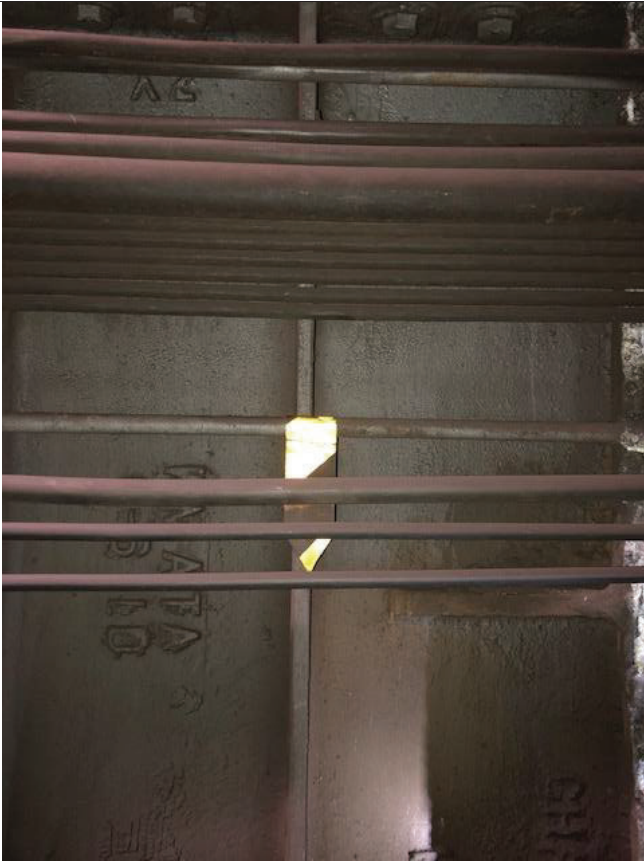
Figure 1: Between D04 and D05, all grab handles were behind wires and conduit.
