## Integrated Wheel/Rail Characterization through Advanced Monitoring and Analytics

OCTOBER 2019

FTA Report No. 0145  
Federal Transit Administration

**PREPARED BY**  
MTA/New York City Transit  
2 Broadway, New York, NY 10004

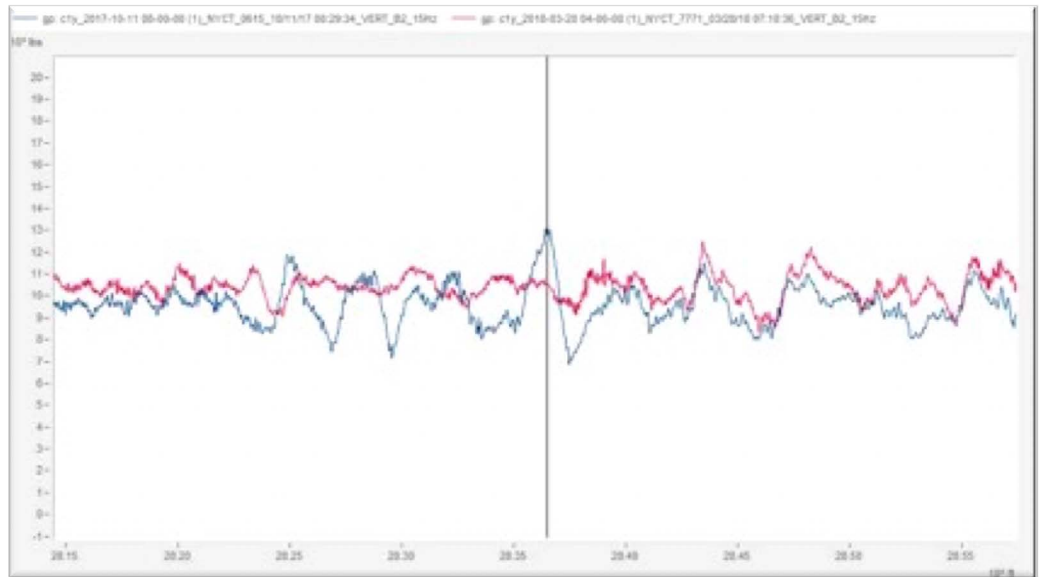
**Figure 5-6**  
 Vertical dip measured  
 by geometry car at  
 Woodside Station on  
 CM track

A Priority 1 track geometry defect (dip on track surface) was identified by a track geometry car inspection in October 2017. IWS data showed that there was a vertical force peak at the same location (Figure 5-6, blue trace). After the defect was corrected, the vertical force peak disappeared, which confirmed effectiveness of the maintenance activities (Figure 5-6, red trace).

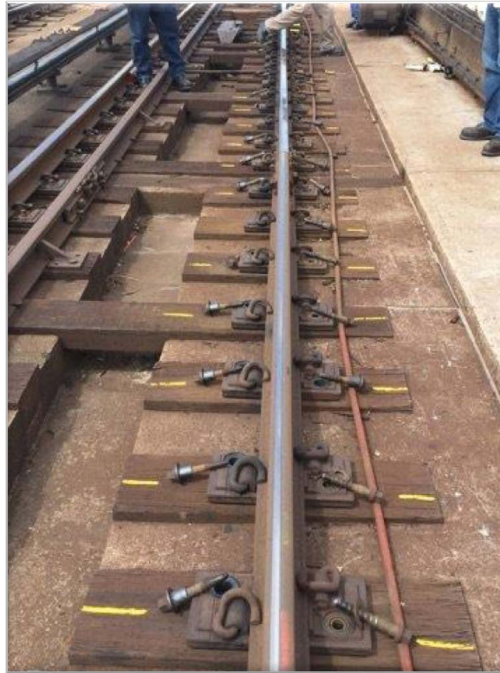
**Figure 5-8**  
Loose spikes on track  
C1 between 40<sup>th</sup>/46<sup>th</sup>  
St stations

The straight section of track between the 40<sup>th</sup>/46<sup>th</sup> St stations was identified by MTA track forces as having long clusters of loose spikes (Figure 5-8). Review of the vertical vibrations (Figure 5-9) found no noticeable change between April 2018 and June 2018 after the spikes had been replaced.

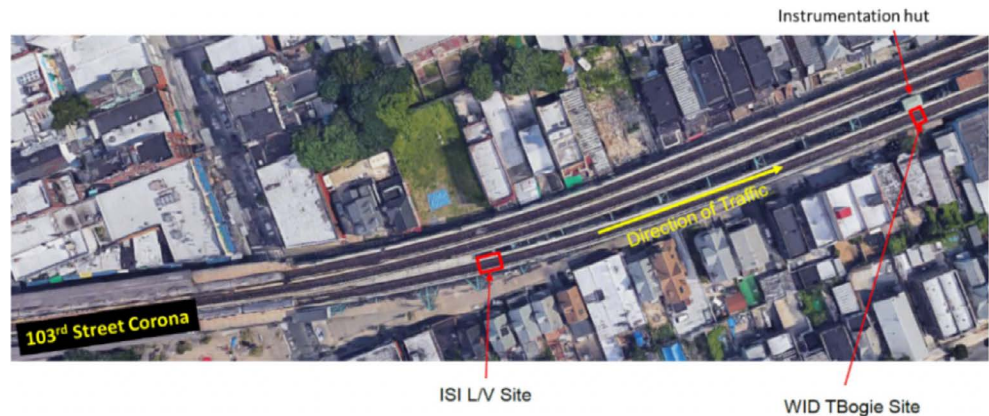
**Figure 5-18**

The TBOGI and L/V instrumentation are located on track C2 line just north of the 103rd St (Corona) station (see Figure 5-18). The L/V is located on a short, unrestrained curve of 1780-ft radius (3.2 degrees), with a super-elevation of 2.75 inches and a posted speed of 50 mph. Due to its proximity to the station, it is likely that the head end of the trainset will run slower than the trailing end through that site. After passing the curve, and roughly 300 ft further along, the TBOGI is located on tangent track. In the span of one week, a given car might pass the wayside instruments as many as 130 times. Figure 5-18 shows the physical location of the L/V and TBOGI sites on MTA's Flushing Line (#7 train) in Queens.

*Layout of wayside test sites*
